Scott Home Inspection, LLC
Complete Home Performance Assessment
970-532-2424
www.ScottHomeInspection.com

Inspection Report

Property Address:
456 Elsewhere Ct
Boulder CO

Inspection Date:
9/2/2014

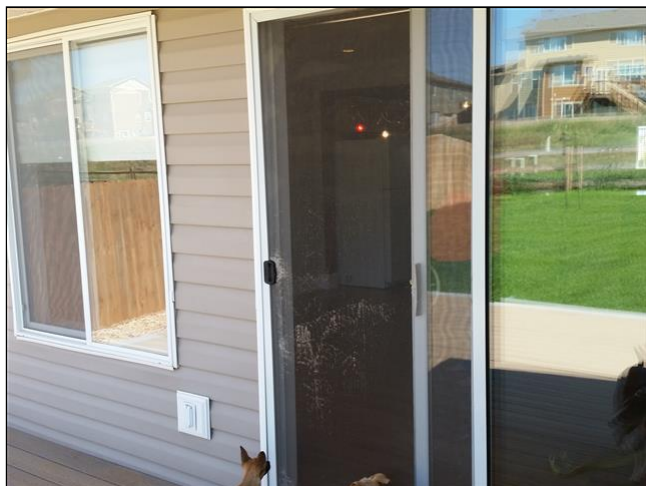
1.2 Item 1(Picture)

The screen door at the sliding glass door is damaged and torn. A screen door repair or replacement is needed.

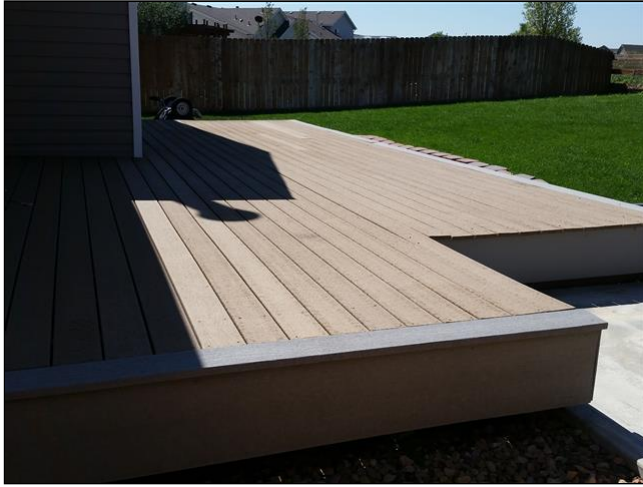
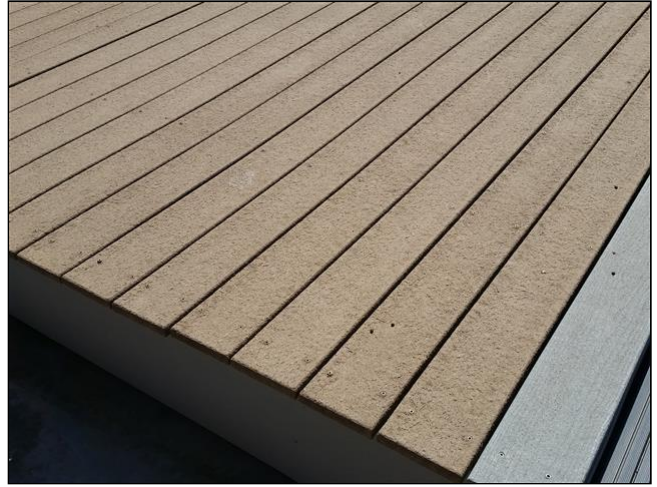
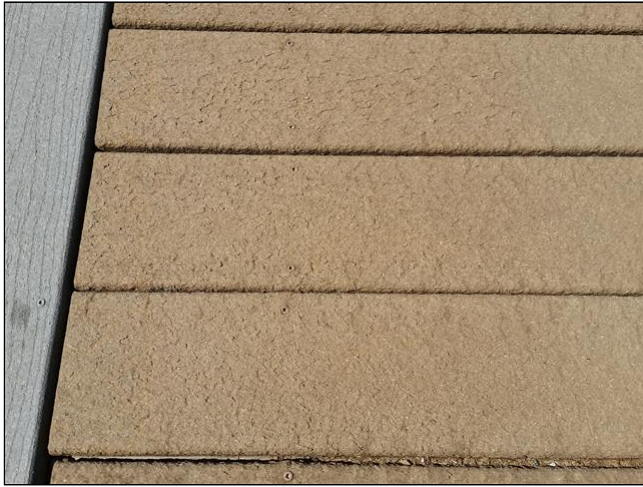
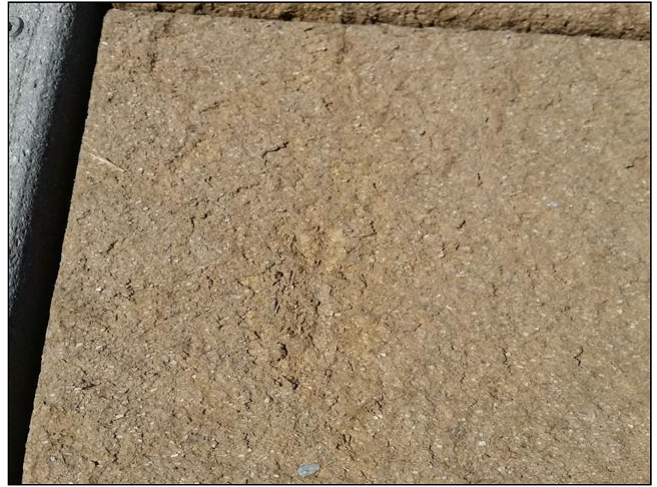
The rear deck composite decking material is deteriorating in an abnormal way, as the surface appears to be flaking away. This may be a manufacturer's defect. The deck boards will likely need to be replaced. A deck professional should evaluate and advise on repair/replacement options and costs.

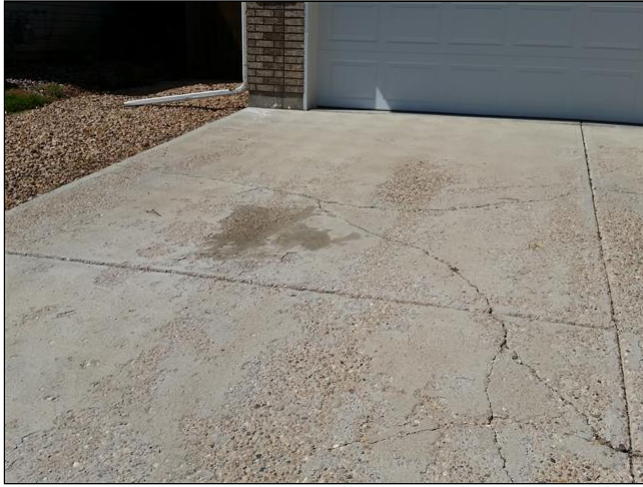
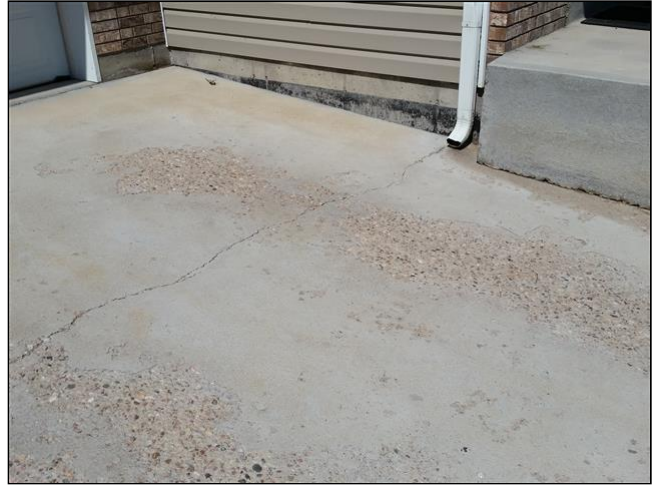
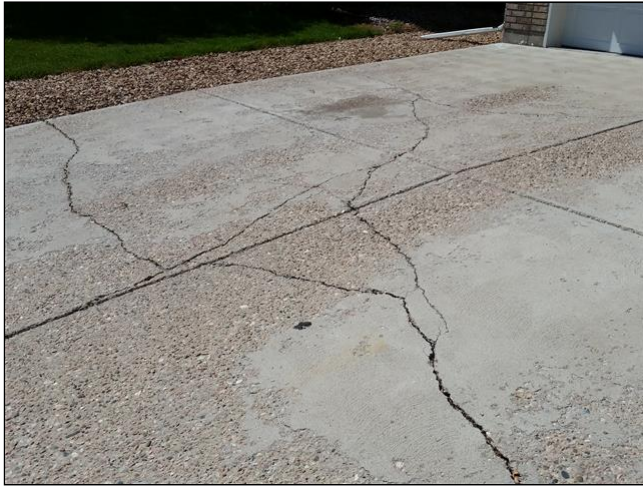
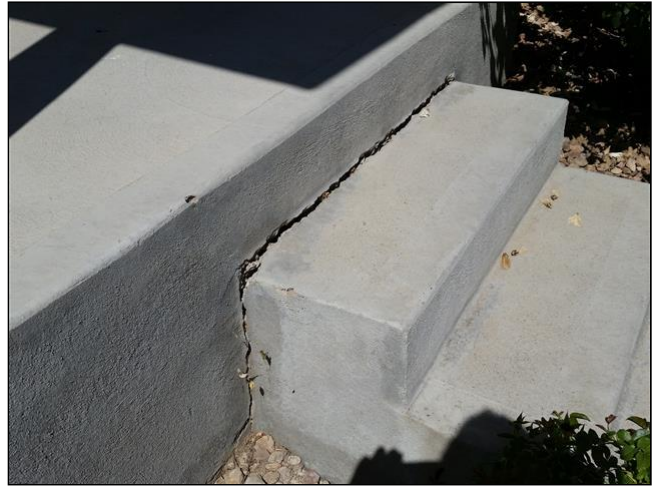
The concrete drive for the home is pitted and shows significant surface deterioration and cracking. The cracking is likely due to minor settling and appears cosmetic in nature. The pitting and surface wear, however, are abnormal, and may be the result of freeze damage during the original curing process, or it could be related to the use of snow melt products. Re-surfacing or replacement of the driveway should be considered, to prevent further deterioration. Consult with a concrete professional for repair/replacement options and costs. Otherwise, the cracks in the concrete should be caulked or sealed, to prevent moisture penetration and further cracking.

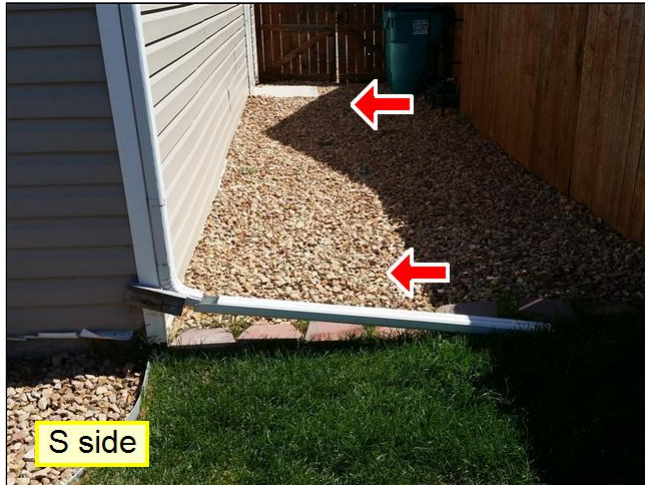
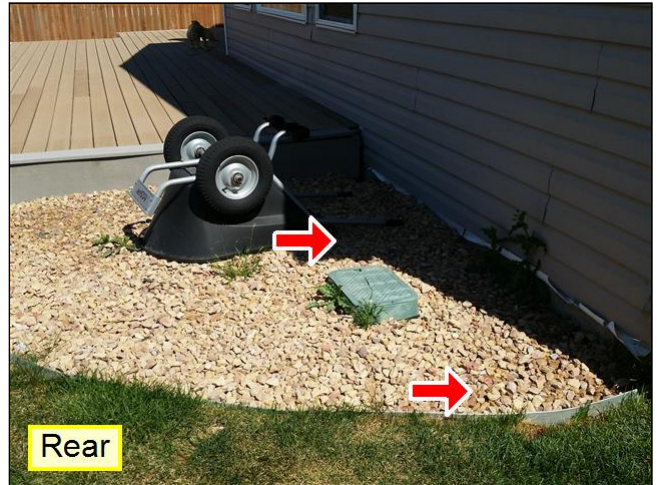
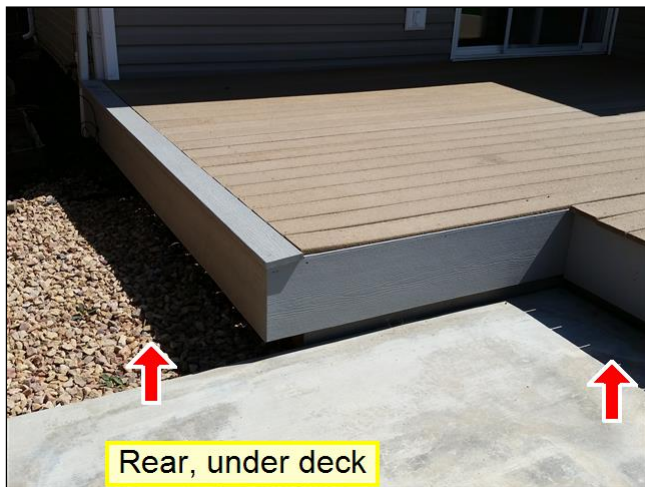
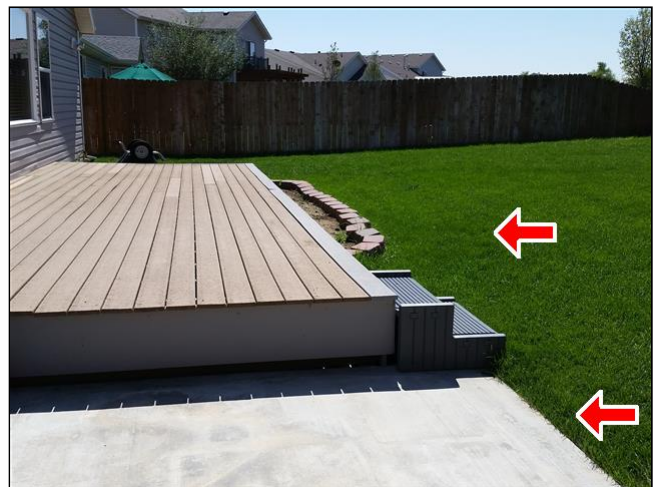
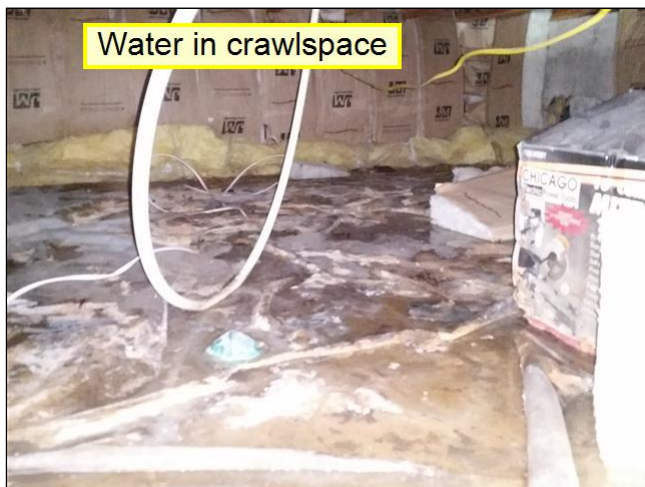
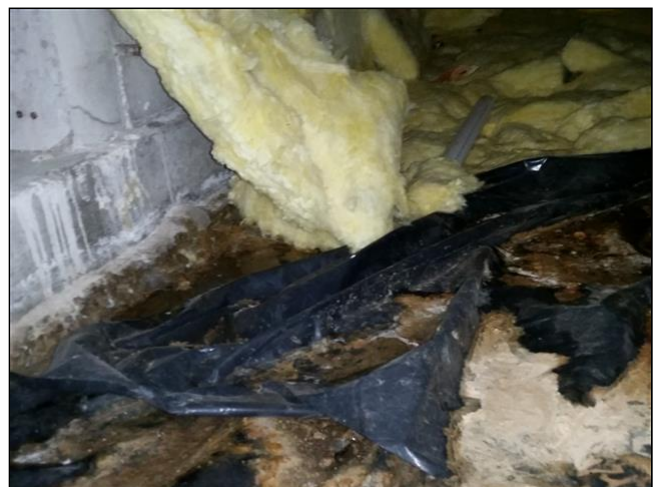
There is a flat or negative slope to the landscaping all around the home, which can cause or contribute to water intrusion or deterioration. Moisture concerns are currently noted in the crawlspace, which appear to be at least partially caused by this poor drainage. To prevent mold/moisture damage in the crawlspace, and to prevent long-term structural concerns, the landscaping and slope need to be corrected. A landscaping or drainage professional should further evaluate and repair the drainage as needed.

There is a flat or negative slope to the landscaping all around the home, which can cause or contribute to water intrusion or deterioration. Moisture concerns are currently noted in the crawlspace, which appear to be at least partially caused by this poor drainage. To prevent mold/moisture damage in the crawlspace, and to prevent long-term structural concerns,

the landscaping and slope need to be corrected. A landscaping or drainage professional should further evaluate and repair the drainage as needed.

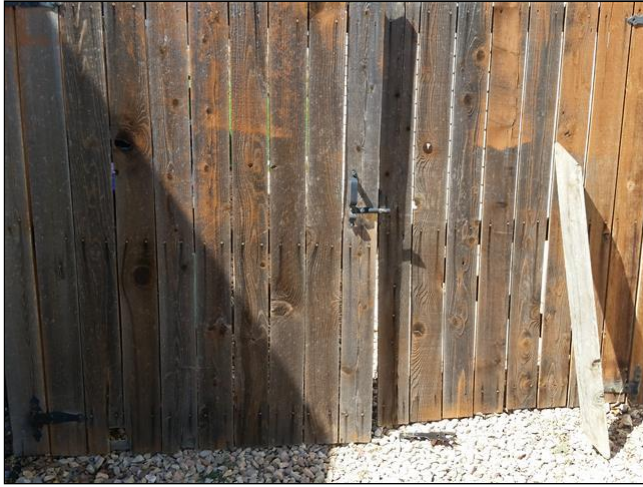
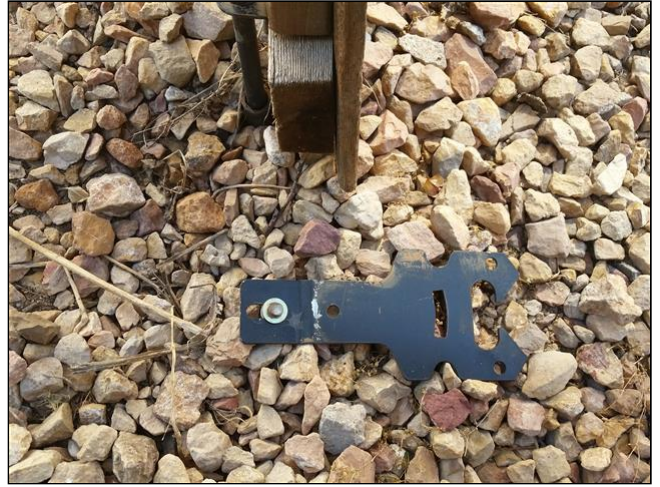
The fence gate on the left side of the home will not close or latch properly, as the latching mechanism is loose or damaged. A repair or adjustment is needed.

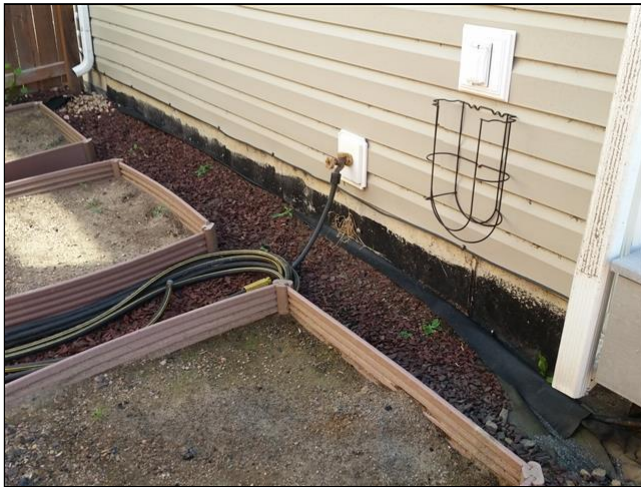
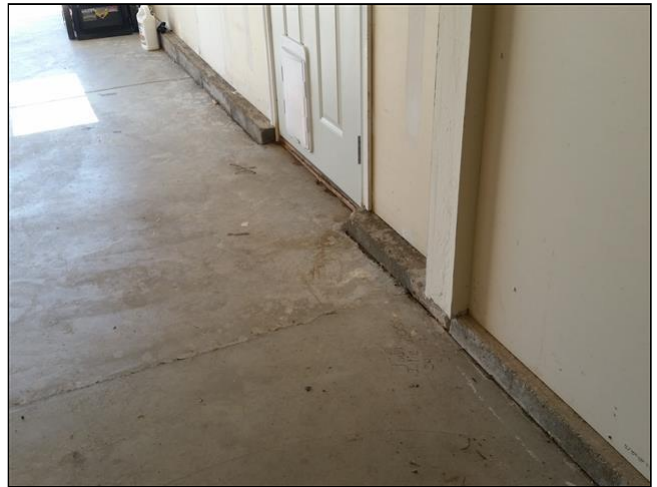
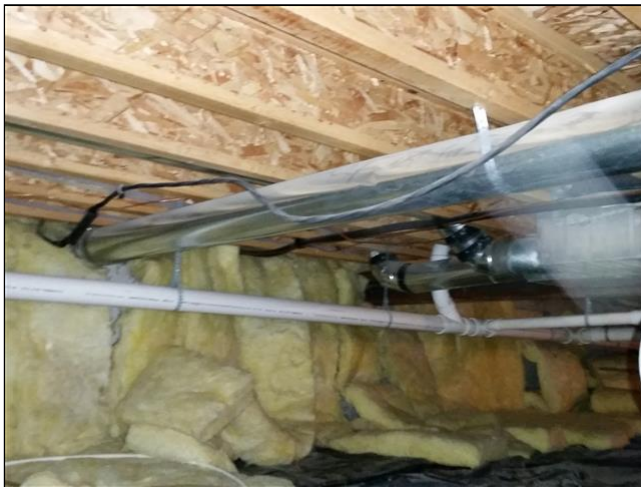
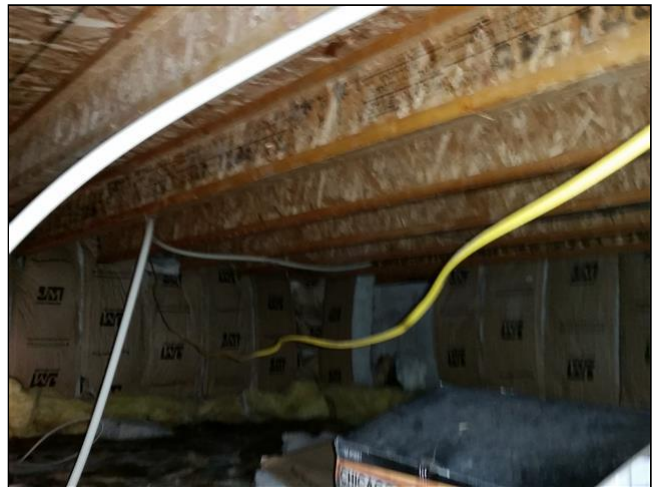
The structure and foundation of the home were visually inspected where visible for signs of problems or concerns. The exterior and interior wall coverings were also inspected for indications of settling, movement, or cracking. No indications of structural concerns were observed at the time of the inspection.

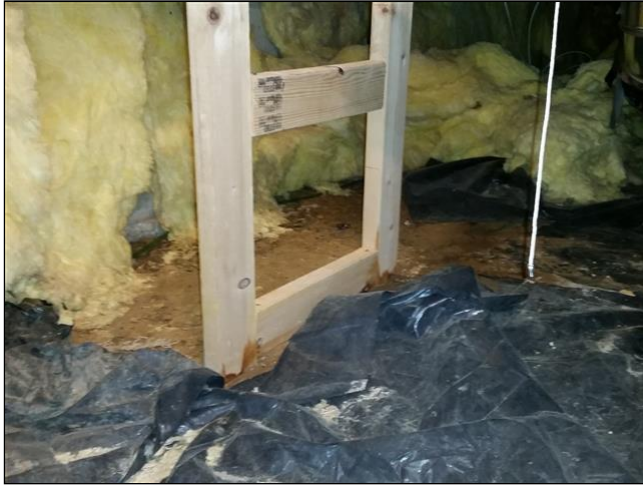
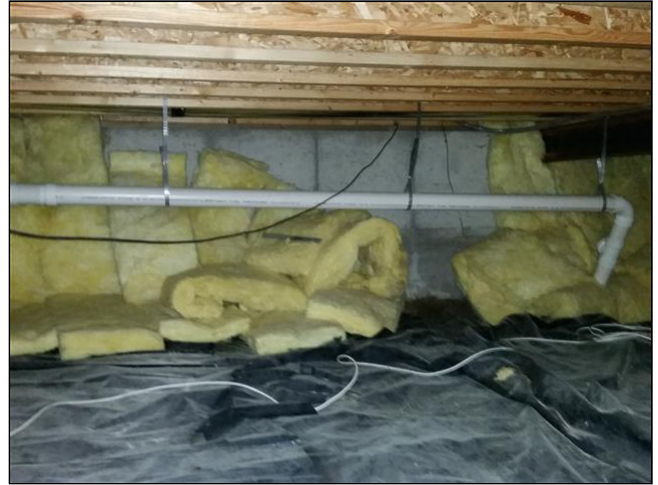
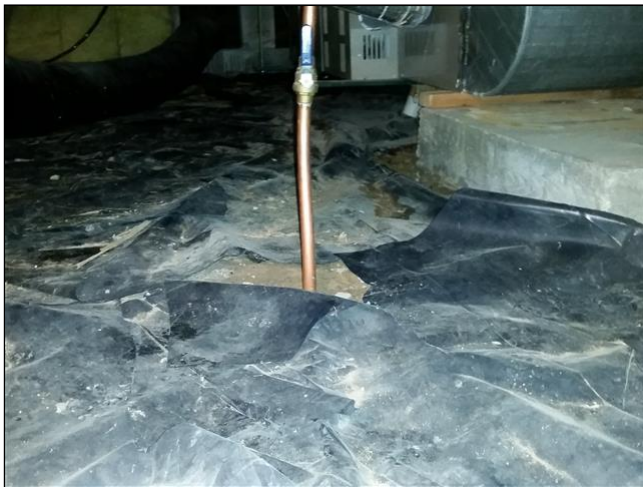
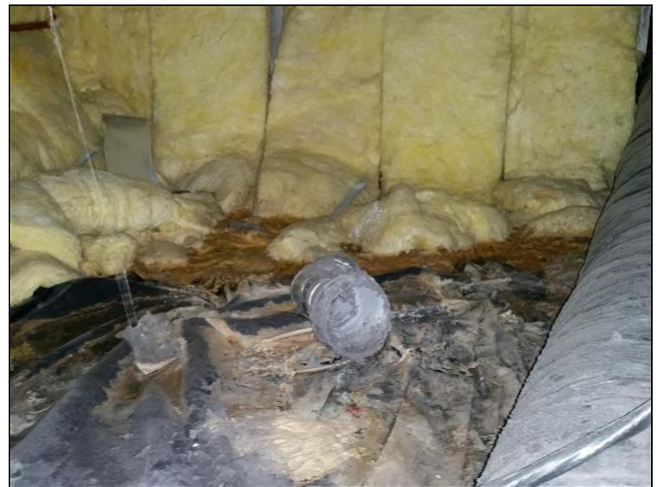
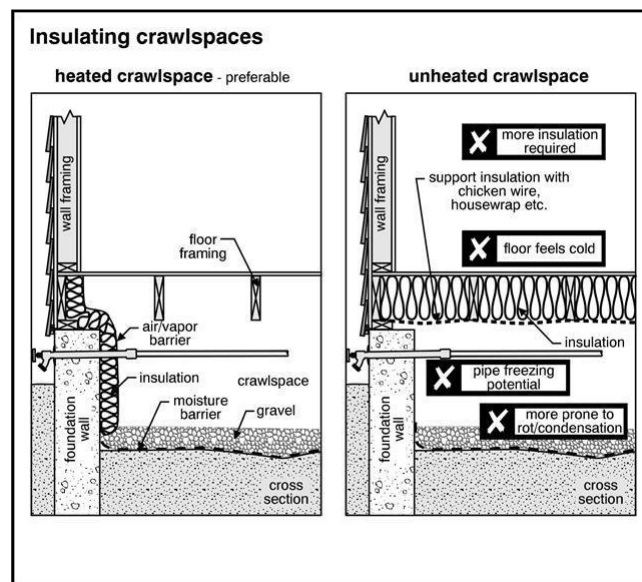
The vapor barrier (plastic) on the crawlspace ground is missing in areas and is not sealed at the seams or edges. A vapor barrier provides added protection to the floor system from moisture or dampness that can enter from ground. The plastic that is present appears to be damaged or too short at the edges to be adequately sealed. Currently, there is moisture on top of the vapor barrier, as noted earlier in section 1.6. Once drainage issues are corrected, I recommend that a new plastic sheet vapor barrier be installed over the soil, secured to the edges of the foundation wall, and sealed on all seams throughout the crawlspace. Also, the insulation is damaged and loose in several areas due to moisture damage, and it appears likely that all of this insulation will need to be removed and replaced.

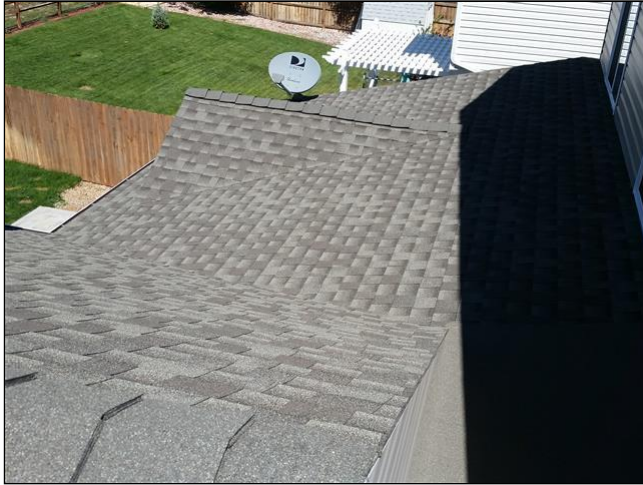
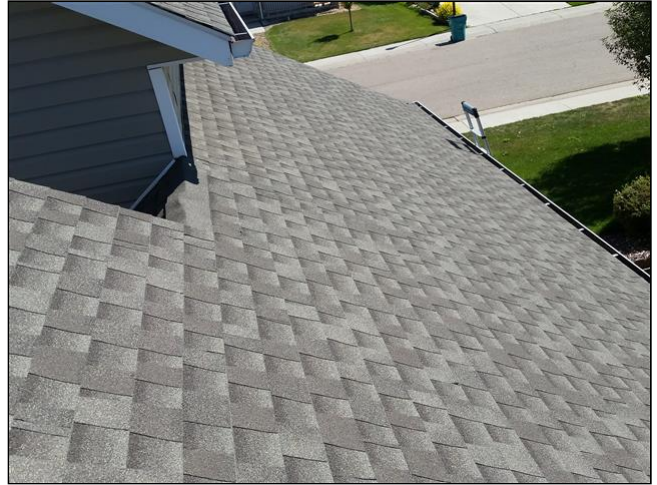
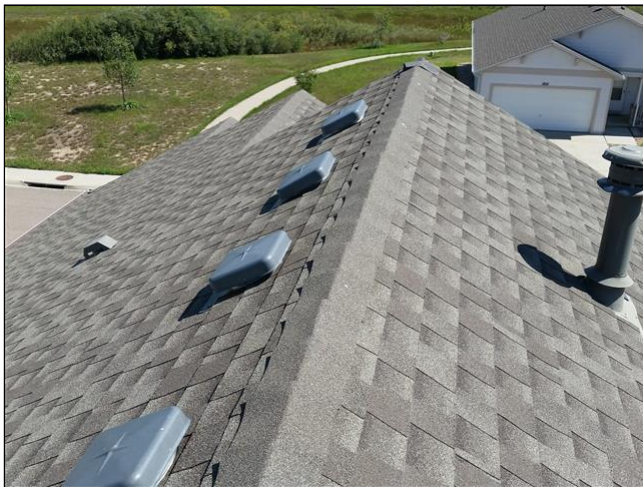
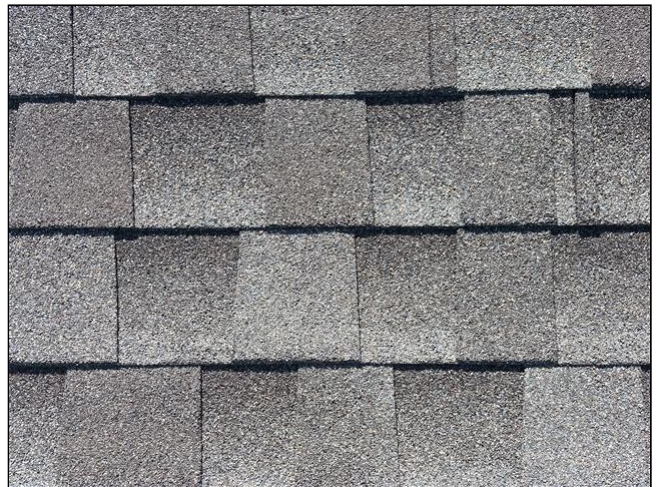
The roof was walked and fully inspected. No concerns or defects were noted at this time.

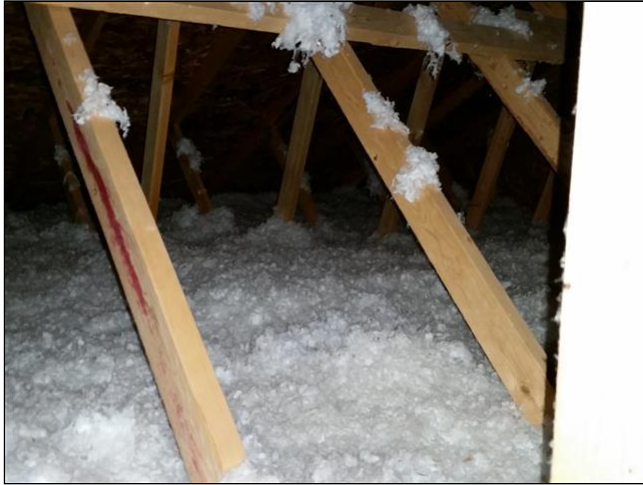
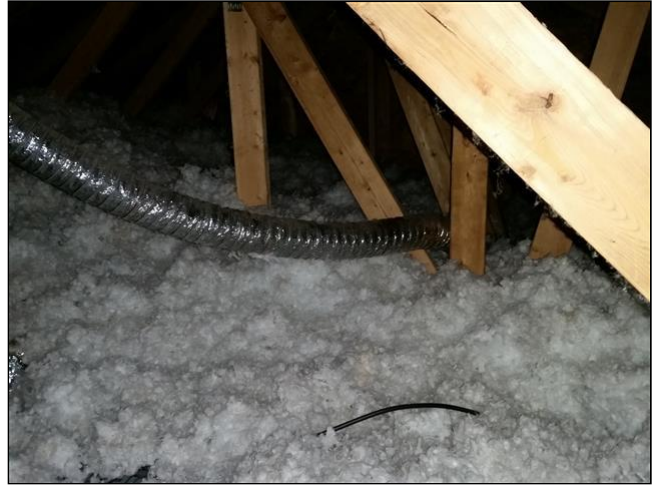
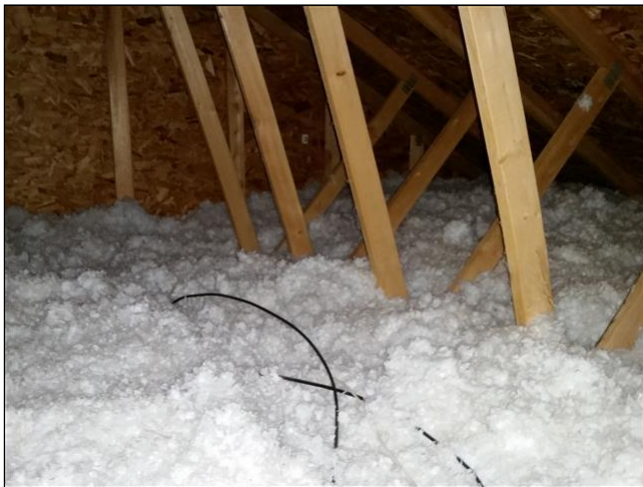
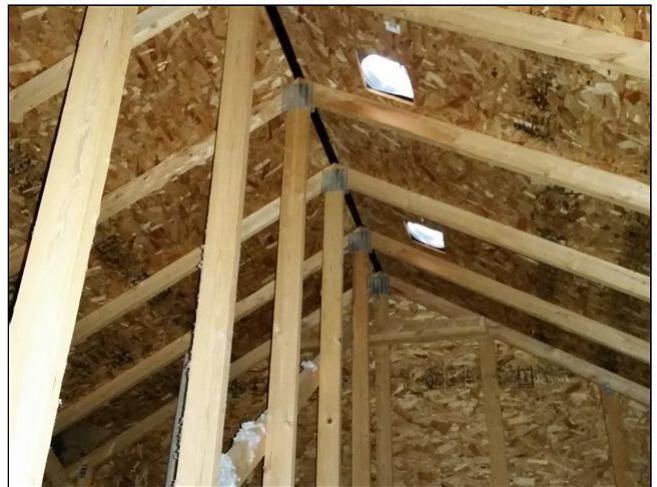
The attic was visually inspected and is properly insulated, with no structural or moisture concerns noted.

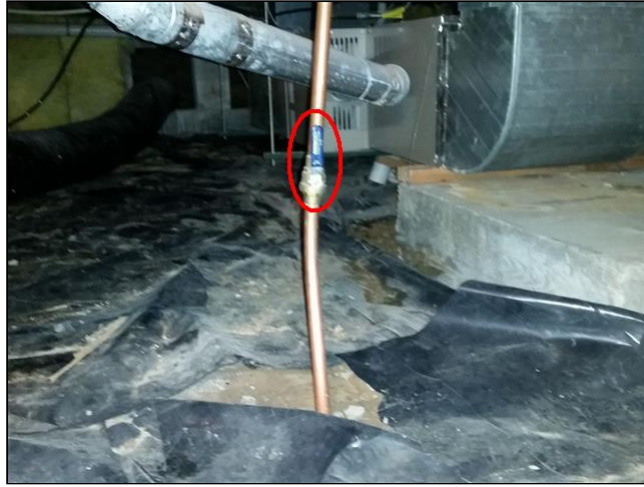
4.1 Item 1(Picture)

The main shut off is the blue lever located immediately inside the crawlspace. This is for your information.

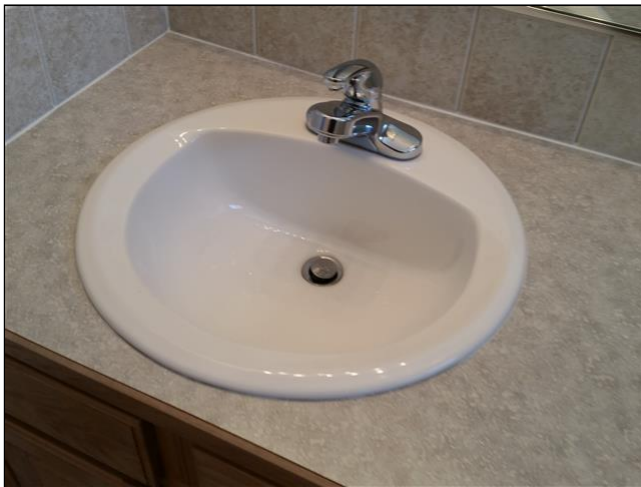
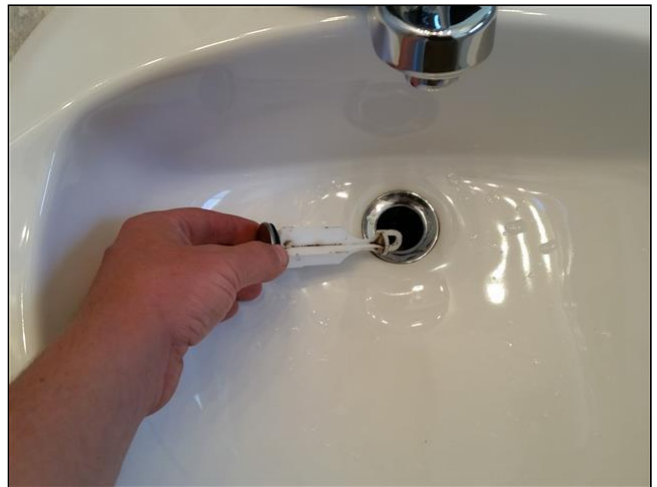
The sink drain stopper assembly is not working in the hall bath. A plumber or qualified person should repair as needed.

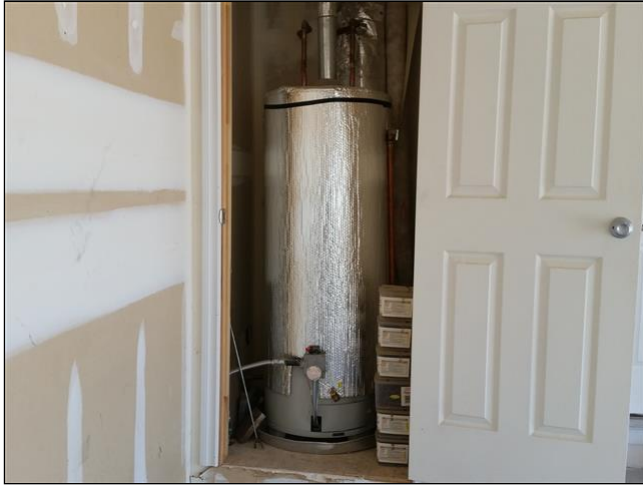
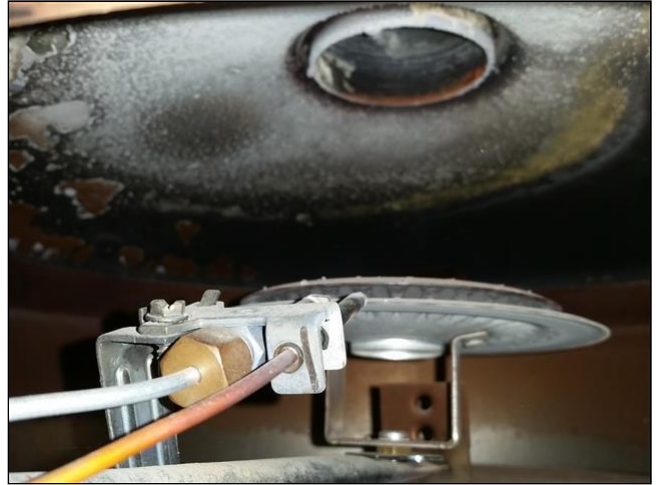
The water heater is older, with a small amount of rusting present in the fire-pot area, and is nearing the end of its life expectancy. Currently no leaks are present. The water heater should be monitored for leaks. The unit will likely need replaced in the near future.

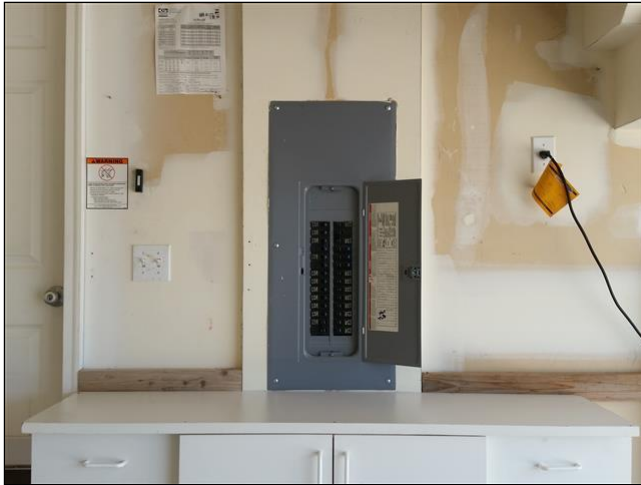
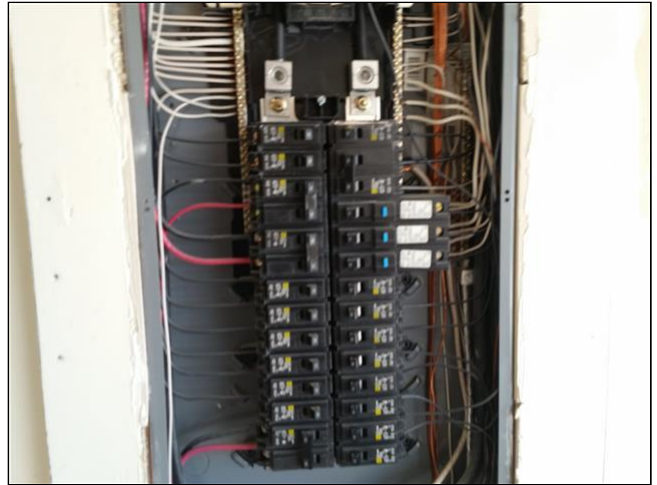
The main panel box is located in the garage. The interior of the panel was inspected, with no concerns noted.

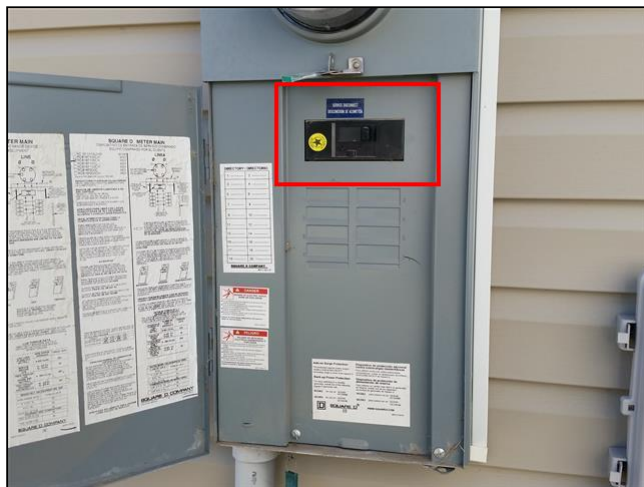
5.2 Item 1(Picture)

The main disconnect is located in the box at the electrical meter at the side of the home.

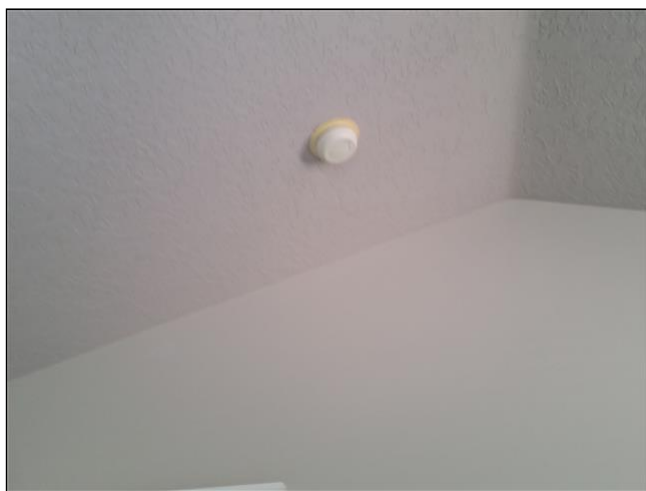
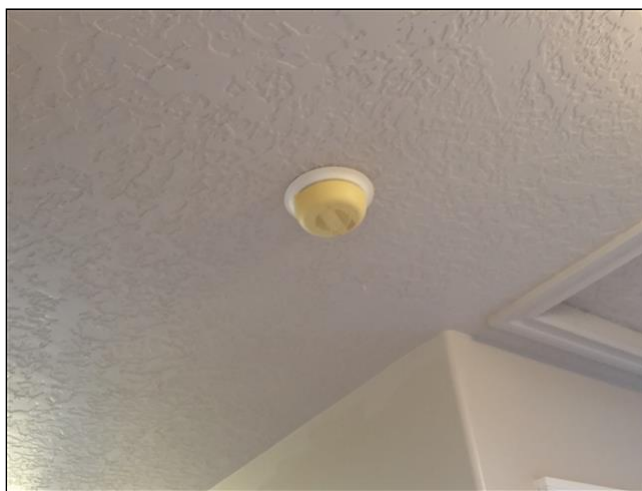
Smoke alarms are present in the home, located on each floor and within each bedroom, as recommended. The units present are hard wired with battery back-up. Monthly testing of the units is recommended, along with annual battery replacement. Additionally, replacement of the units is recommended once older than 10 years of age, according to the National Fire Protection Association. The following article has important tips related to smoke alarm safety: <http://www.nfpa.org/~media/Files/Safety%20information/Safety%20tip%20sheets/smokealarmssafetytips.pdf>

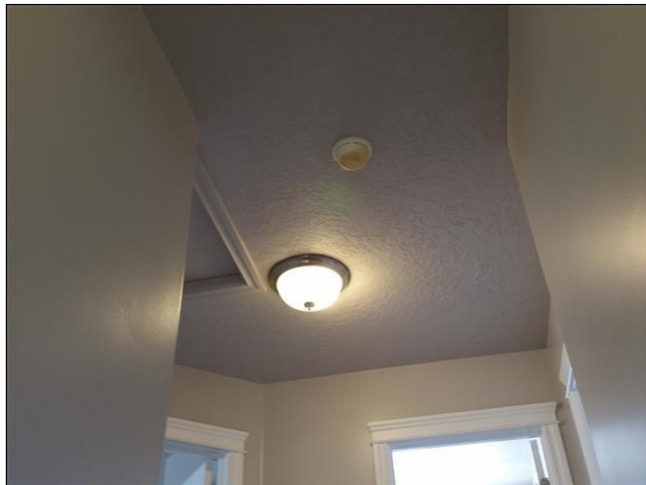
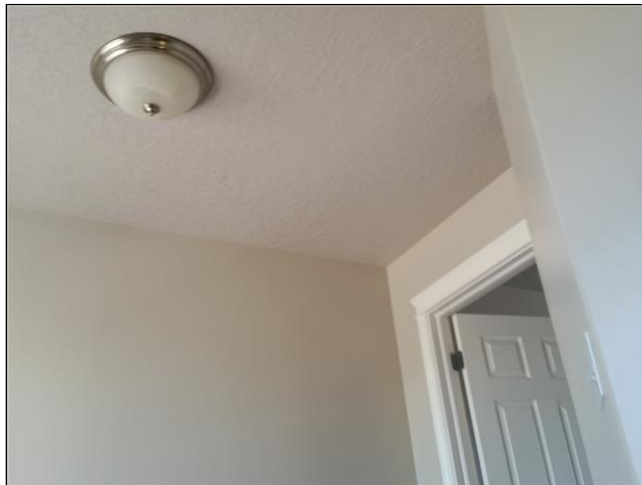
Effective July 1, 2009, all homes being purchased are required to have Carbon Monoxide Alarms installed by the seller. This is a requirement for homes that have a fuel-fired heating system or appliance, a fireplace, or an attached garage. The CO

Alarm(s) must be installed within 15 feet of the entrance to each sleeping room. This can be in a hallway outside bedrooms. If bedrooms are located on more than one level, then a separate CO alarm must be installed outside each bedroom area on each level. This inspection includes a review of the presence of CO alarms, and includes pressing the 'test' button to verify operation. **There are no CO detectors present in the home - units need to be added outside all bedroom locations.**

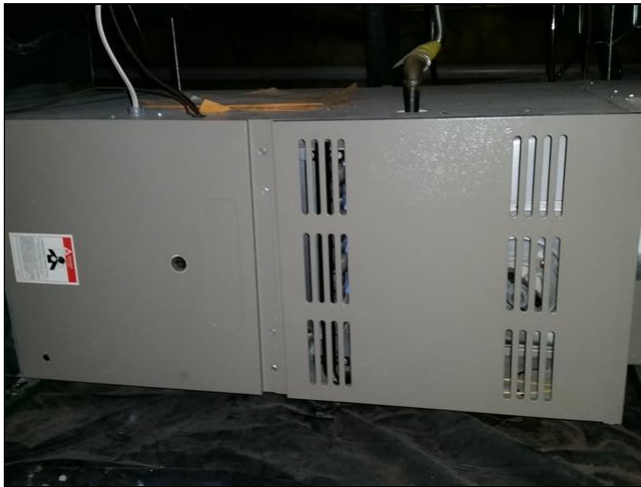
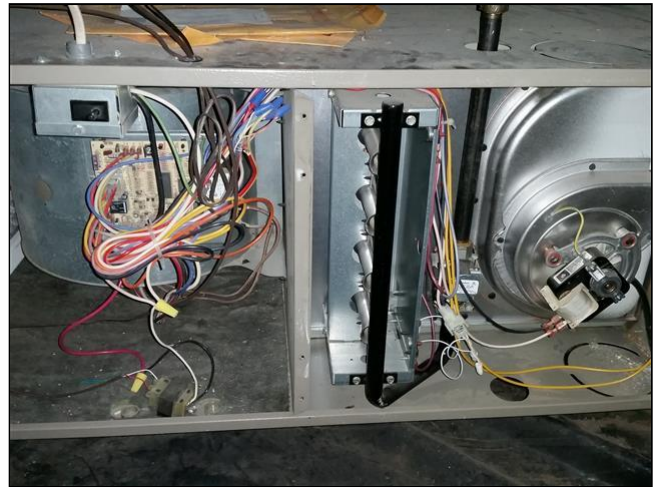
The furnace is located in the crawlspace area. The furnace has a build up of dust inside it and within the fan assembly. While the unit functioned normally, I would recommend a service check be done to clean and service the unit. An HVAC company should perform this service.

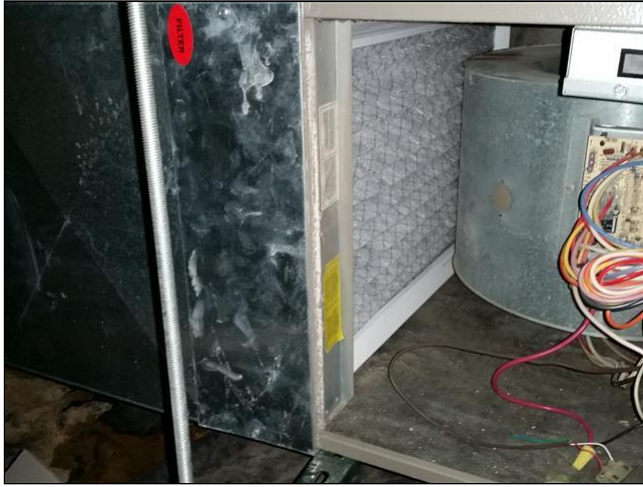
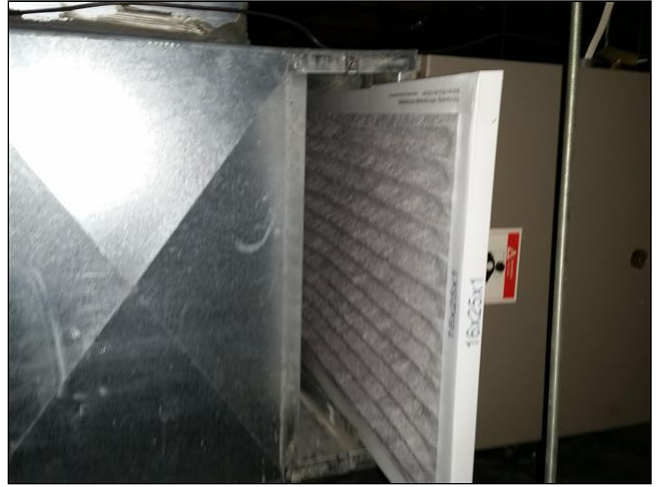
The filter is clean and is currently located at the furnace.

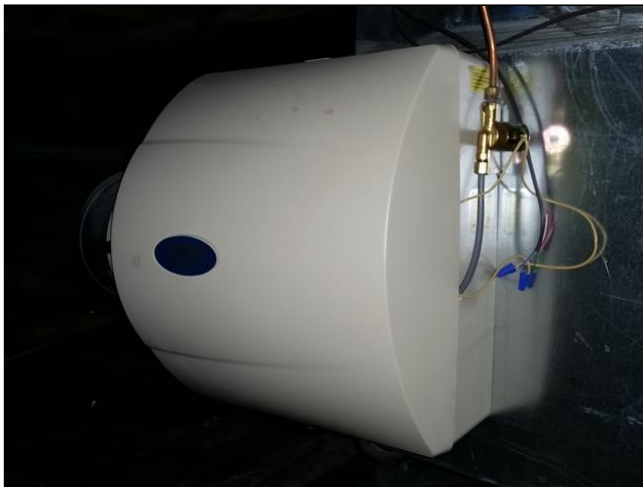
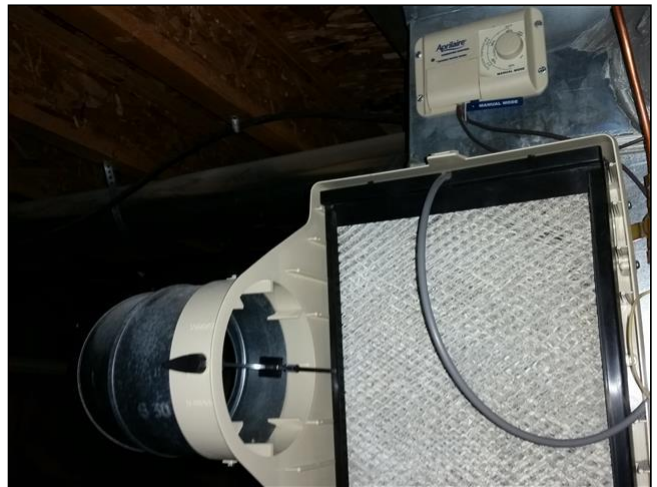
There is a humidifier installed on your heating system. We perform a limited visual inspection of these items. The unit is inspected for leaks in the supply line and condensate line. The unit appears to be operating properly, with no leaks noted and no concerns observed.

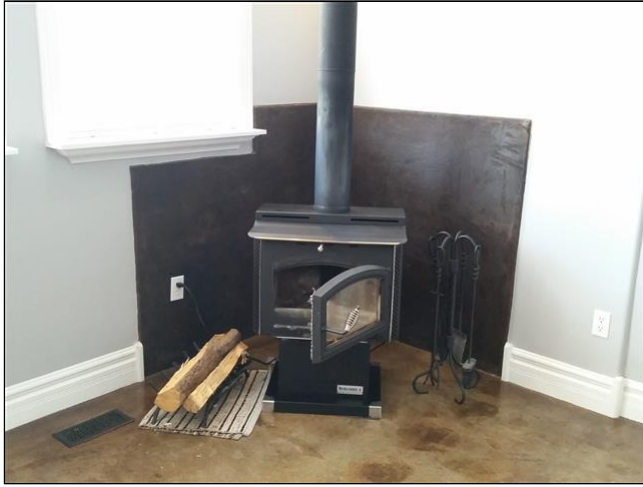
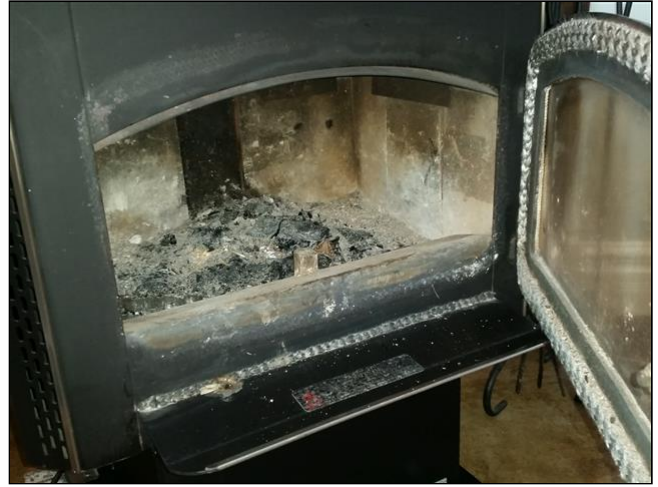
The woodstove was visually inspected, and appears to be in good working condition, with no concerns noted. Consider having the unit professionally cleaned before using.

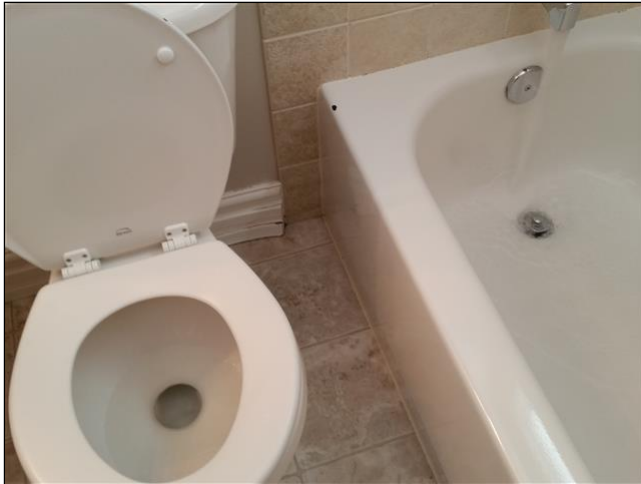
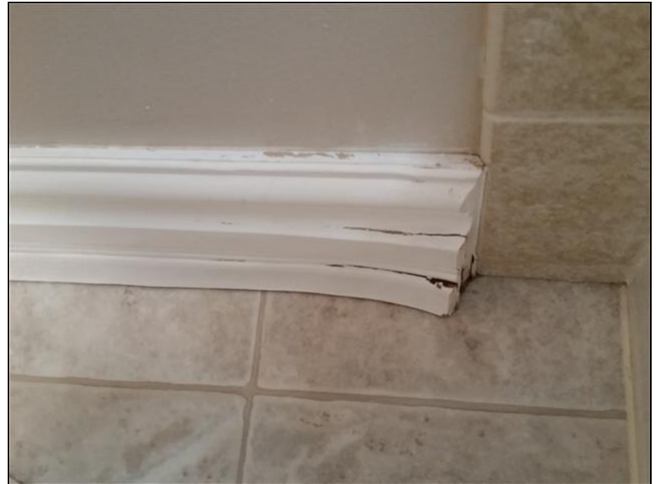
Minor moisture damage was present at the upstairs hall bathroom to the baseboard behind the toilet. This appears to be the result of moisture absorption from water that had escaped the shower. This baseboard should be removed and replaced, and sealed as needed.

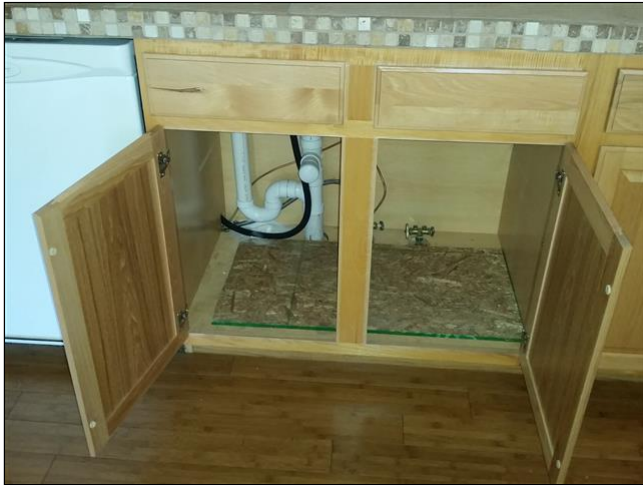
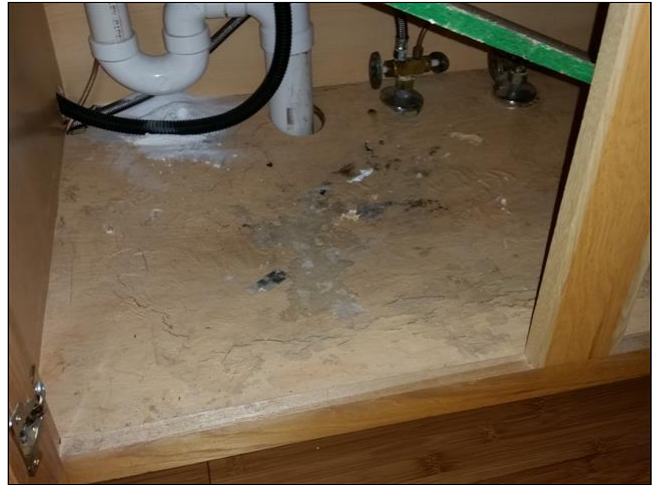
The base cabinet next to the dishwasher has signs of old moisture damage present, with the base not level. While no leaks are present at this time, this wood base should be replaced, to provide a level surface for storage items.

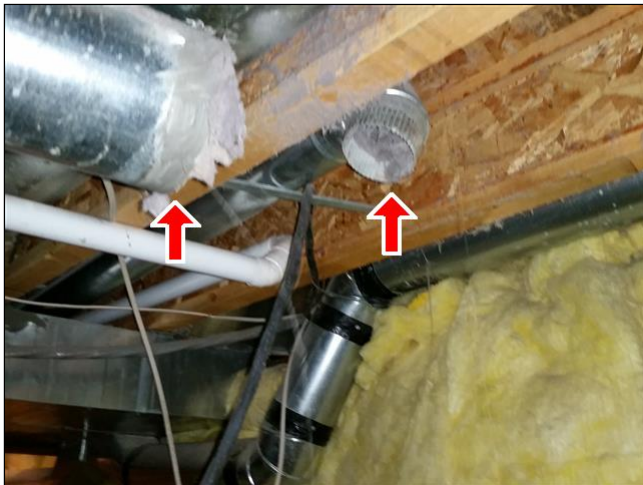
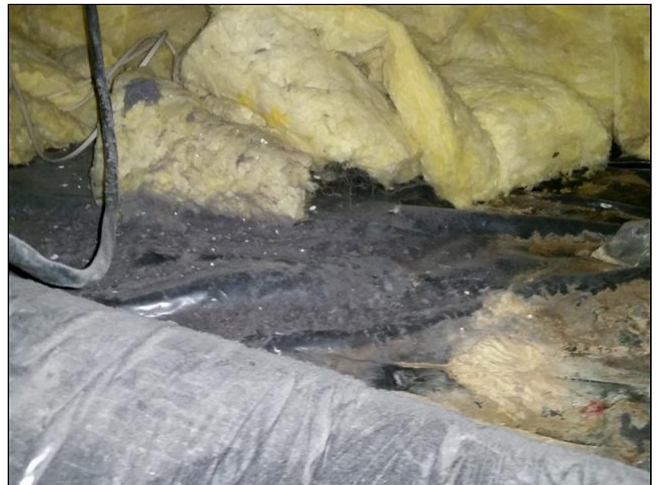
The dryer vent terminates or has become disconnected in the crawlspace, and is no longer venting to the exterior as needed. This will introduce lint and warm, moist air into the crawlspace, which can contribute to mold growth. A qualified contractor should reconnect the dryer vent piping at this time.

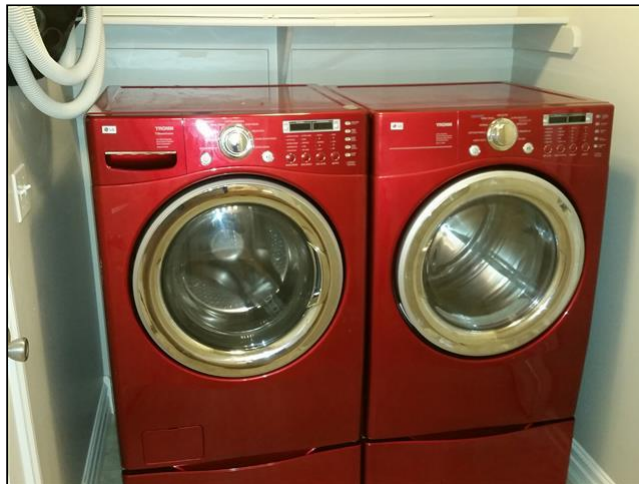
9.0 Item 1(Picture)

The washer and dryer were run briefly to check for any leaks, and for proper heat from the dryer. No concerns are noted with this limited functional test. This is not a complete test, but a limited functional test to verify general operation.

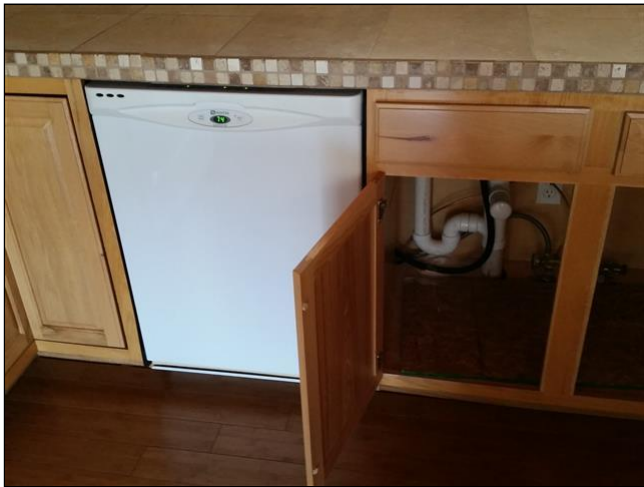
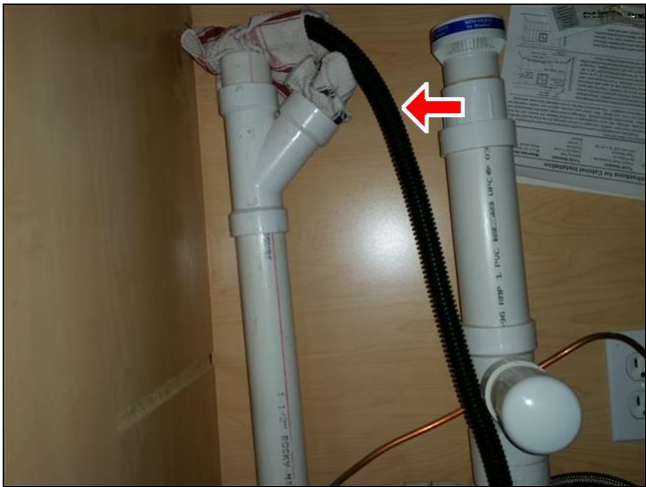
The dishwasher drain line running under the kitchen sink needs to be secured to the drain pipe with a clamp or plastic zip-tie. This is done to ensure the drain line does not come loose from the waste line, and damage the cabinet and surrounding area. This is a minor repair item.

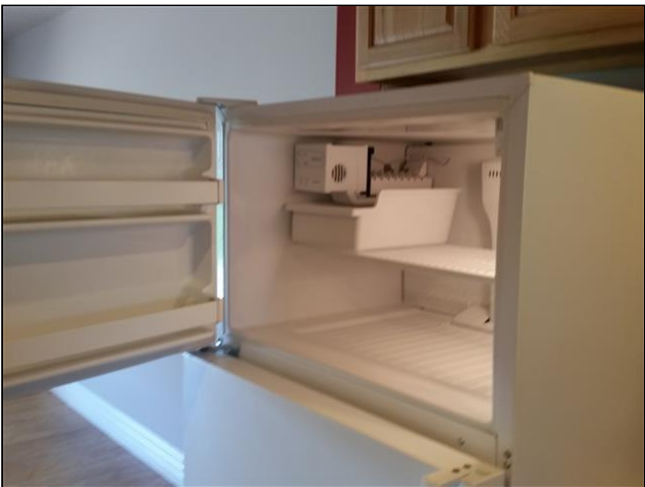
9.5 Item 1(Picture)

While there is an ice-maker on the refrigerator, the ice making unit is currently shut off inside the freezer, and I am unable to verify operation. Consult with seller to determine if this is operating properly.

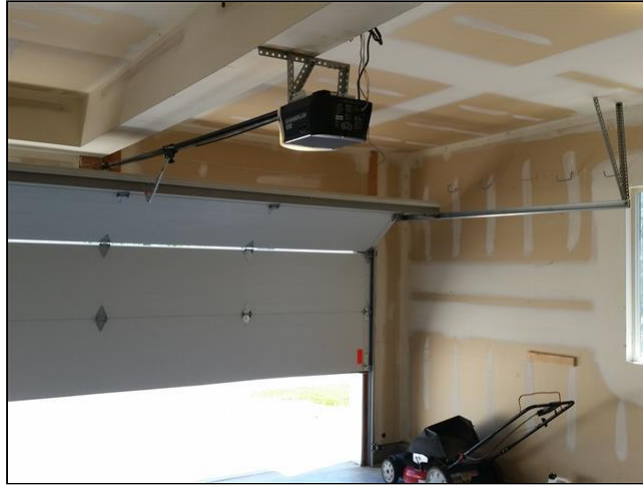
10.4 Item 1(Picture)

The garage door will reverse when the photo-sensor beam is broken. This is a safety check performed, to test the safety feature of the door opener.
