Scott Home Inspection, LLC
Complete Home Performance Assessment
970-532-2424
www.ScottHomeInspection.com

Inspection Report

Property Address:
456 Elsewhere Ct
Boulder CO

Inspection Date:
9/2/2014

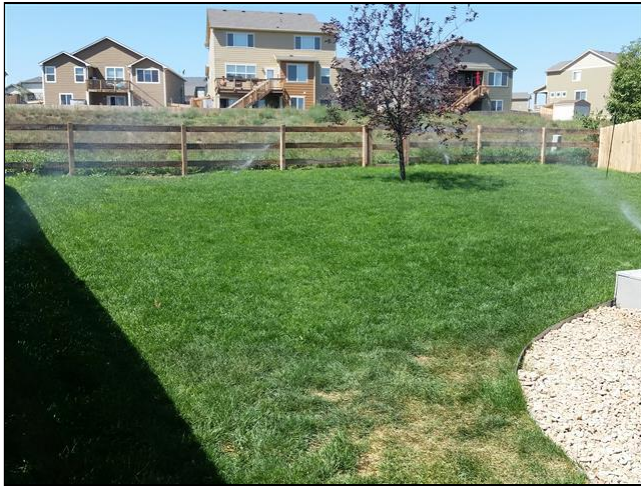
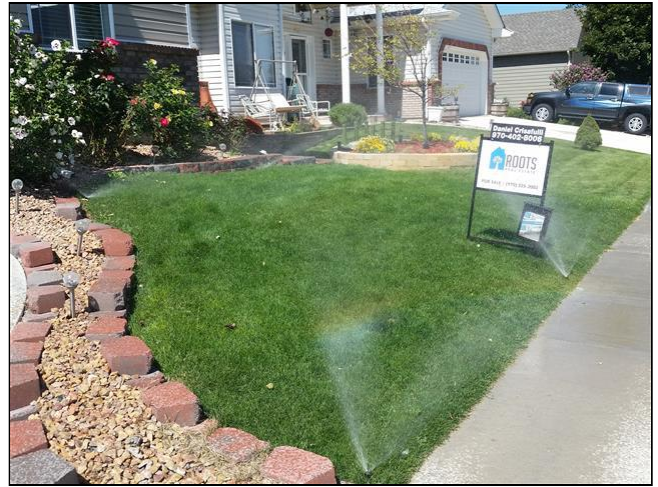
The lawn sprinkling system appears to be supplied by a common well that is maintained by the HOA. Consult with the HOA for more information. Otherwise, a brief cycle through each sprinkler zone was done to ensure no leaks or broken heads exist. The system appeared to operate properly, with no concerns noted at this time.
