Scott Home Inspection, LLC
Complete Home Performance Assessment
970-532-2424
www.ScottHomeInspection.com

Energy Audit Report

Property Address:
111 Cold House Lane
Anytown CO

Date: 10/28/2014	Time: 8:51 AM	Report ID: EAsample
Property: 111 Cold House Lane Anytown CO	Customer: Anonymous Incognito	Real Estate Professional:
Style of Home: Single Family	Age Of Home: Over 25 Years	Weather: Clear
Temperature: Below 60

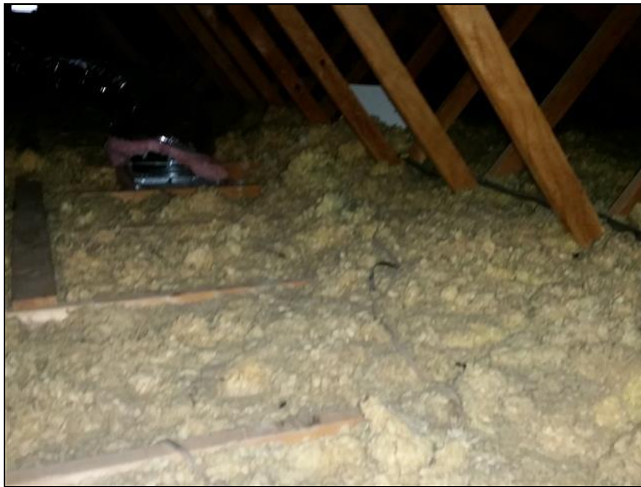
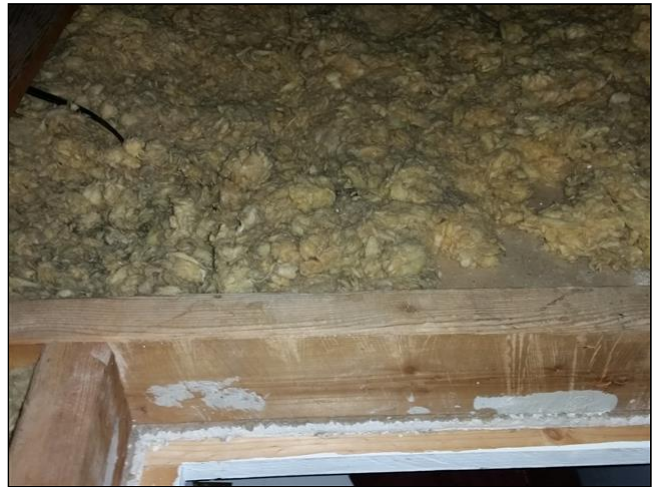
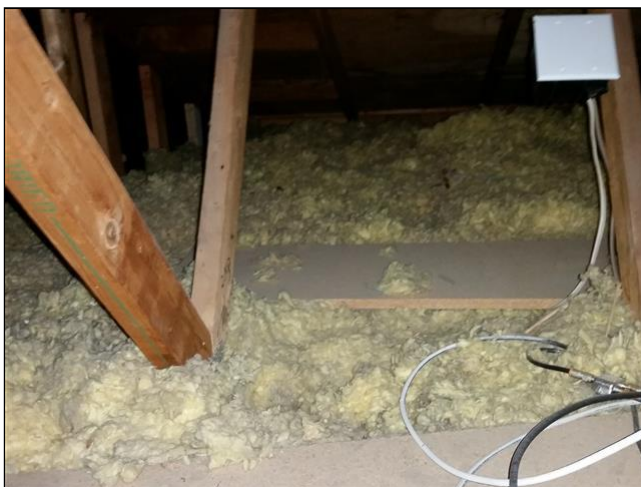
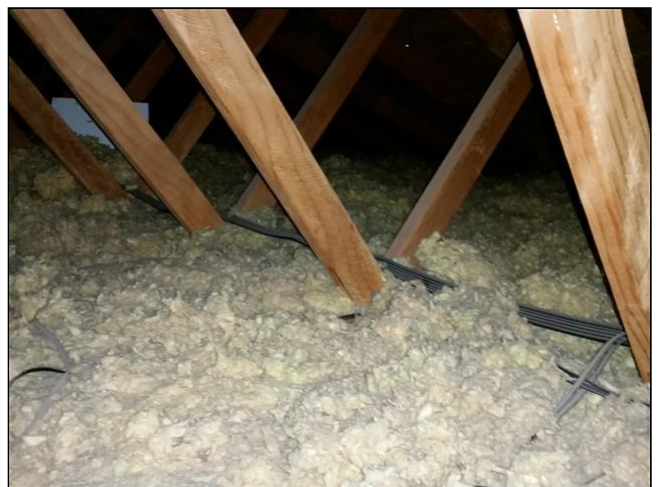
Attic Insulation: The attic is insulated with approximately 3-6" of insulation. I recommend adding another 10" of blown insulation in the accessible areas of the attic. The recommended level of total insulation is R-49 for the attic. Visit the following sites for information on insulation levels: <http://www1.eere.energy.gov/consumer/tips/insulation.html>
http://www.energystar.gov/index.cfm?c=home_sealing.hm_improvement_insulation_table

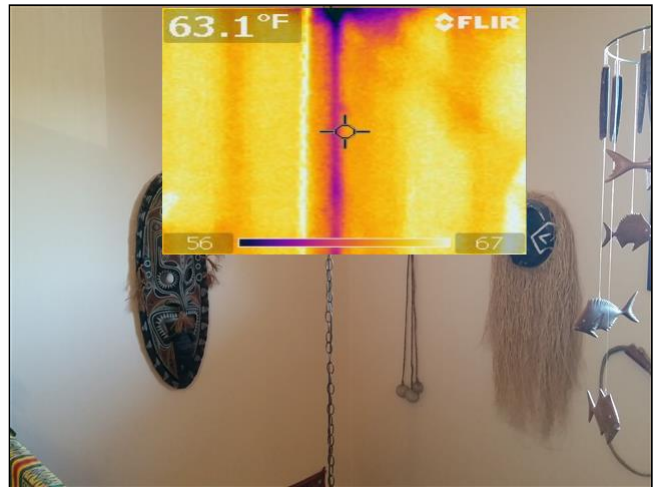
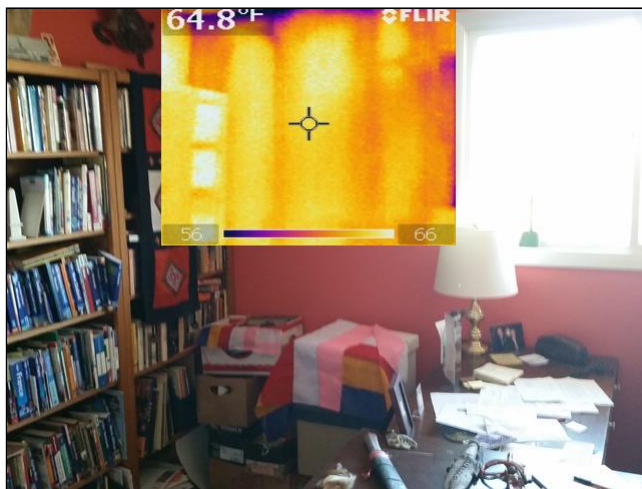
Wall Insulation: a basic inspection of the wall insulation was done using infra-red scans, and observing insulation levels behind outlet plates, where possible. This limited inspection showed that the walls appear to be adequately insulated well at this time. No significant gaps, voids or missing areas were noted.

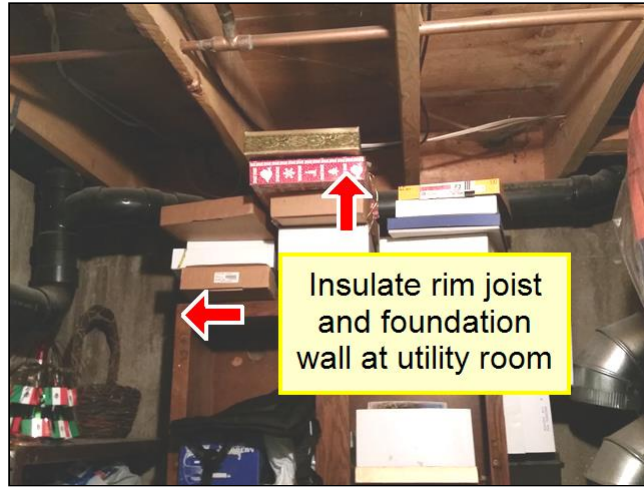
1.2 Item 1(Picture)

Basement Insulation: The basement foundation walls and rim joist area are not insulated at the unfinished utility room. It appears that the finished areas of the basement are insulated. In this utility room, I recommend adding fiberglass batt insulation, or vinyl faced draped insulation, to the concrete walls and adding insulation in the rim joist area where accessible.

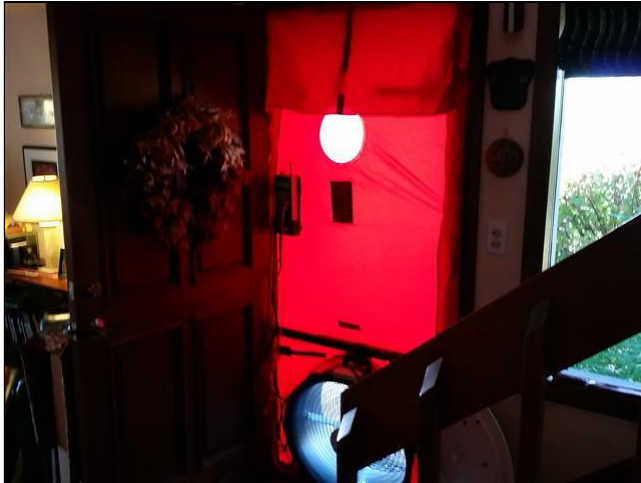
The air sealing in the home needs to be improved. The blower door test measured 2831 CFM at 50 PA, which calculates to 7.6 Air Changes per Hour at 50 PA, or .41 NACH (Natural Air Changes per Hour). A NACH over 0.30 indicates leakage rates where air sealing efforts would be beneficial. The following areas of leakage were discovered and need to be improved.

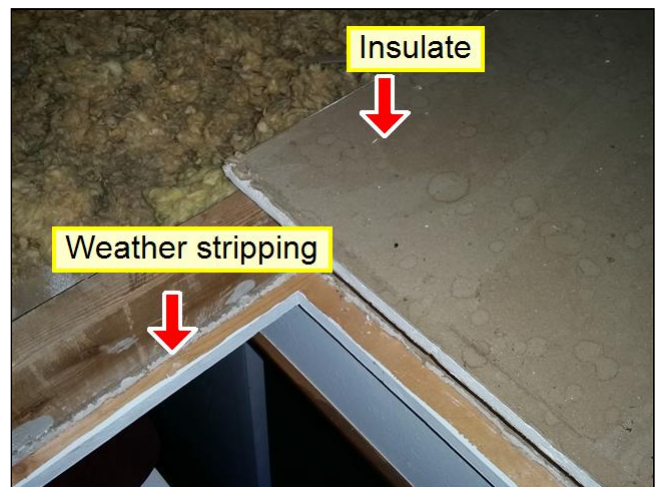
Attic Hatch - Weather-strip the attic hatch edges, so that when the hatch drops, it rests on the weather stripping. Also, ensure the upper part of the hatch cover is insulated to at least R-30. If possible, have tightening cam latches installed to keep hatch securely closed.

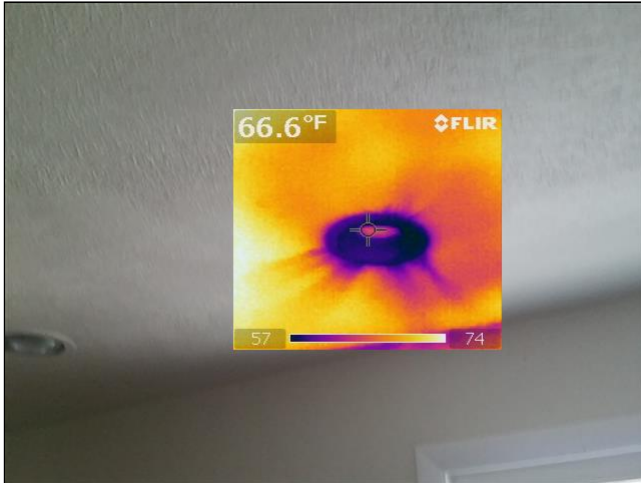
(2) **Ceiling penetrations:** seal the recessed light fixtures and speakers where they penetrate the ceilings at the upper level in the home. The majority of the leakage present is occurring around the edge of the fixtures, in the space between the drywall and the edge of the cans. This gap needs to be sealed. For the lights, seal around the edges with the trim and bulb are removed from inside the home, with an appropriate fire rated caulking. The better alternative is to seal all these light fixtures in the attic, around the edges of the cans, adjacent to the drywall, where access is available in the attic.

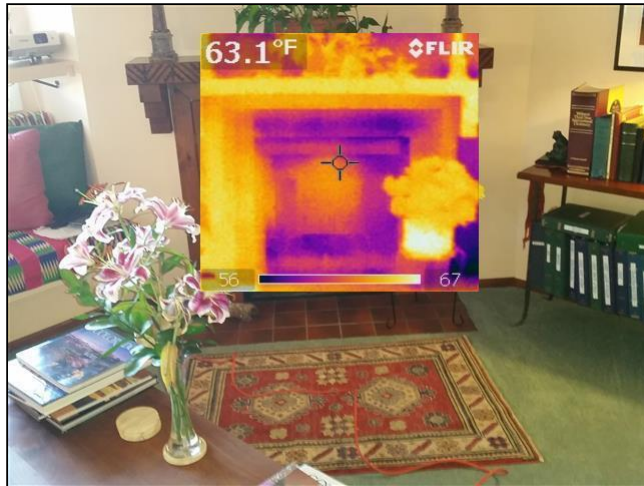
2.3 Item 6(Picture)

- 🏠 (4) Consider installing a glass front door on the fireplace, to help reduce heat loss and air leakage from the flue of the fireplace.

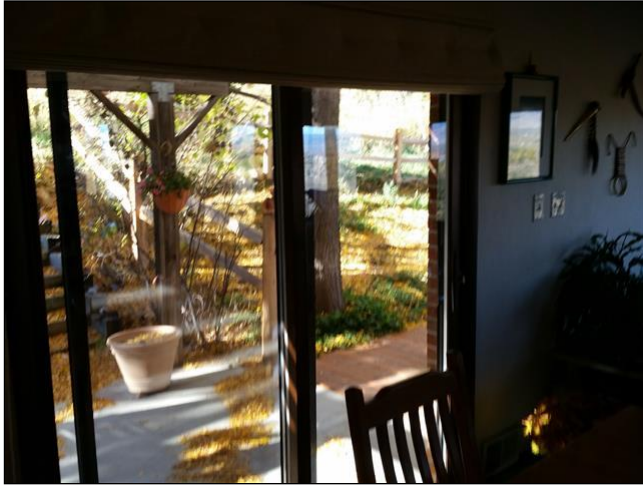
- 🏠 Significant air leakage is occurring at the center stile of the dining room sliding glass door. This door may need repairs, to properly close and seal. A door professional should evaluate and advise on repair/replacement options.

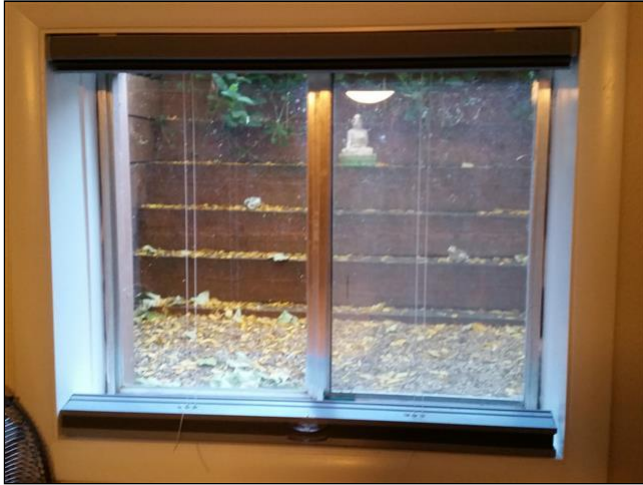
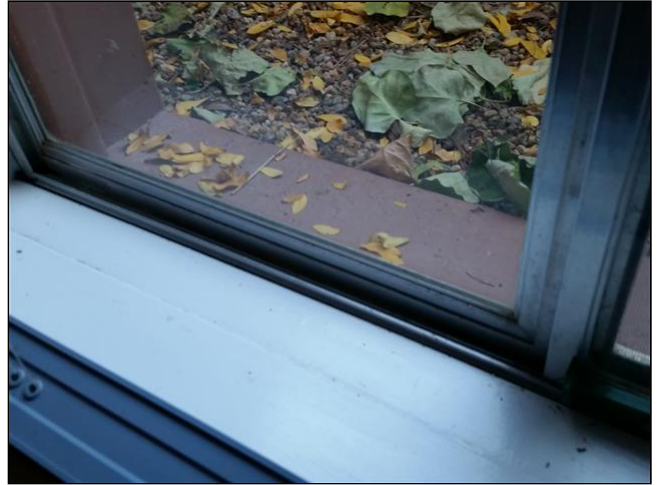
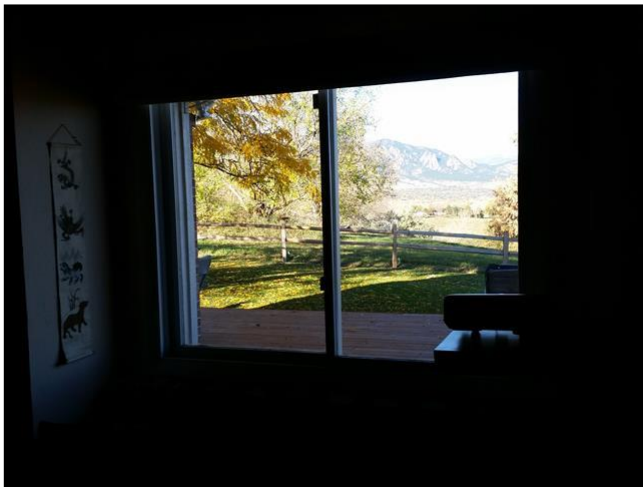
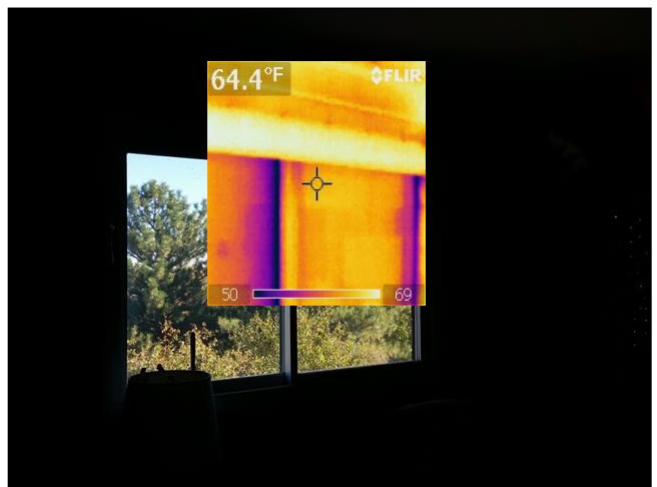
(1) **New Windows:** Several of the windows in your home are single pane or are an older, thin double pane style. There is considerable air leakage occurring at many of these windows, and several do not latch well. I would recommend that you consider replacing the older windows in the future. The following article has a section on windows, and discusses repair versus replacement; https://rmi.org/images/PDFs/HEBs/E04-11_HEB1_Building.pdf

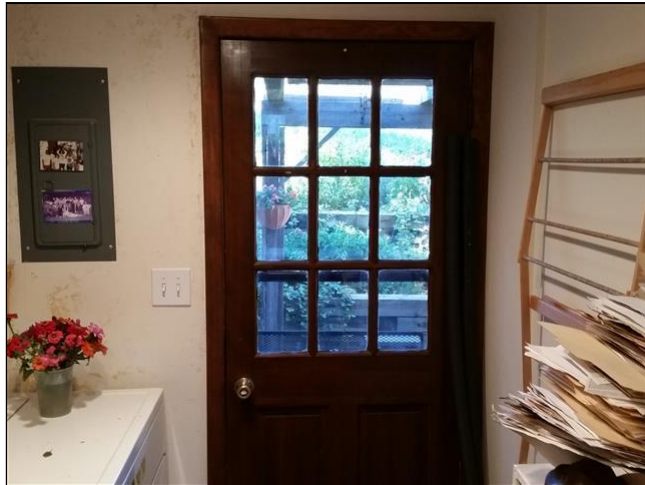
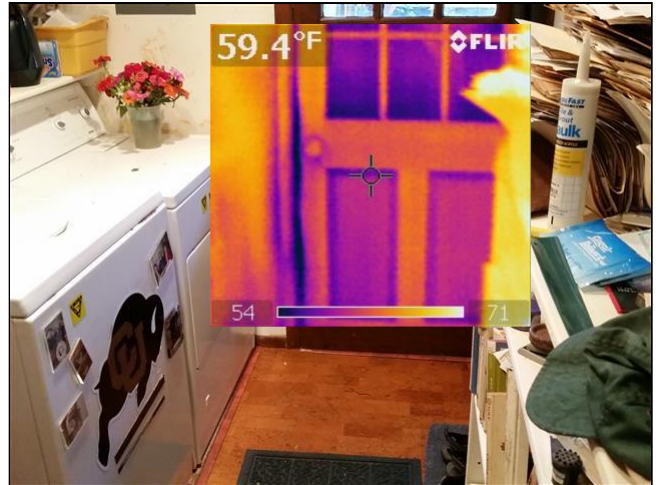
Door Replacement: Consider replacing the rear entry door with a steel or fiberglass, insulated core door. This door is of poor insulating quality, and is likely allowing cold air to conduct into the home.

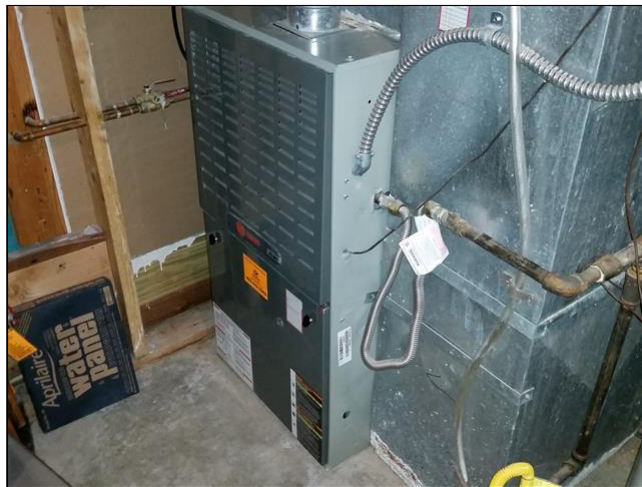
4.0 Item 1(Picture)

**Furnace - Service Check-up Recommended:** The furnace is operating well at this time. I recommend having a service check up done to tune up the furnace and optimize performance, every 2-3 years. Ensure the burner assemblies are cleaned, as well as the other items normally performed. If you are considering replacing the furnace, I recommend you consider a high-efficiency condensing furnace. For information on replacement options, visit the following EnergySTAR website: http://www.energystar.gov/index.cfm?c=heat_cool_pr_checklist_consumers

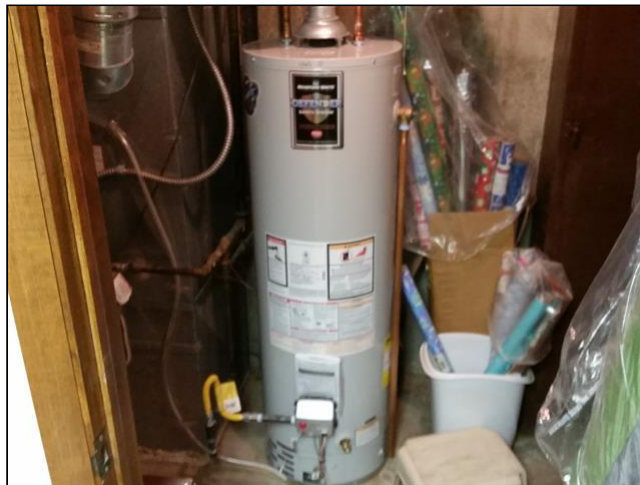
6.0 Item 1(Picture)

Your water heater is currently in good condition, and appears to be operating properly. However, other options exist for efficiently heating water in your home. If you consider replacing your water heater, the following article provides a good overview of alternative options available;
https://www.energystar.gov/index.cfm?c=water_heat.pr_help_me

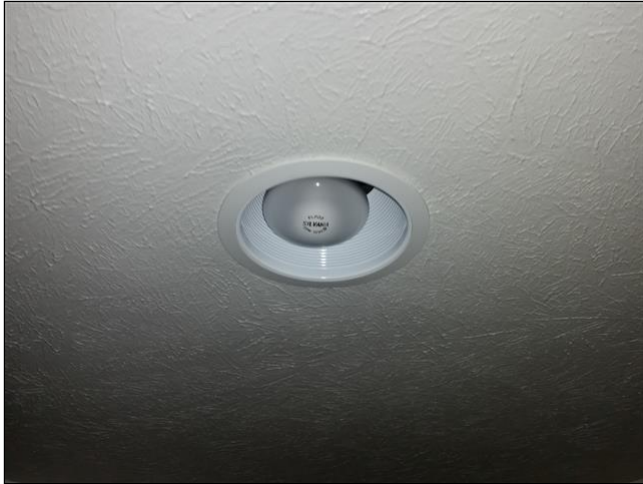
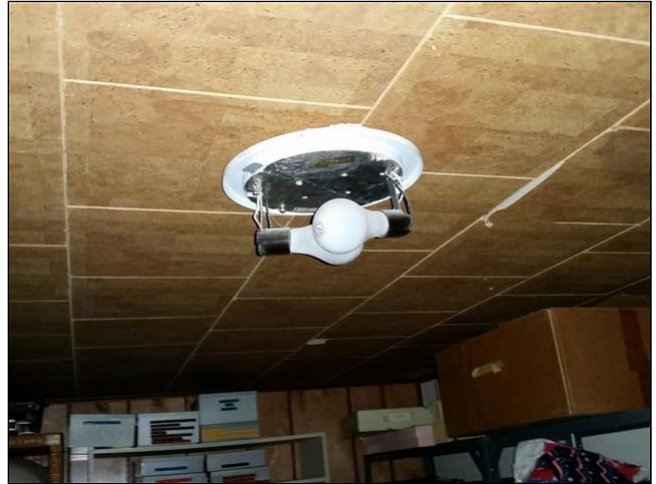
Energy Efficient Lighting: Install more LED's or CFL's in non-dimmed light fixtures. LED and CFL bulbs consume 1/4 the power of incandescent lights, and often last up to 10 times longer. This will help to reduce your overall electric use. For more information visit; <http://www.energystar.gov/products/certified-products/detail/light-bulbs>

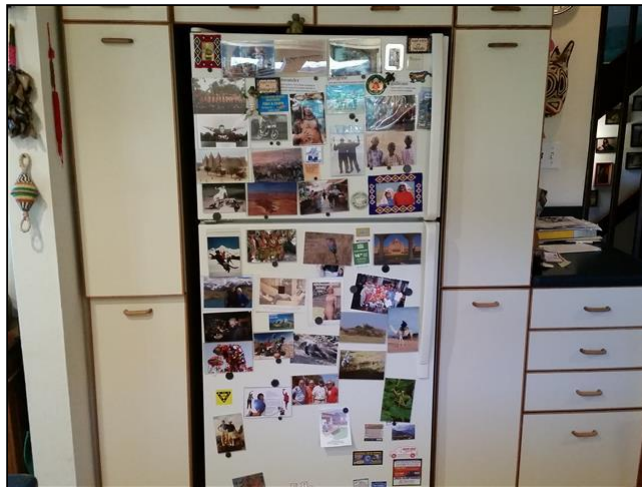
8.0 Item 1(Picture)

Refrigerator: Your refrigerator power consumption is estimated at approximately 665 kWh per year. This is about 2-3 times what a newer Energy Star refrigerator would consume. Consider replacement at this time. As a maintenance item, regularly clean the refrigerator condenser coils beneath or behind the unit to ensure optimum efficiency is gained from your current unit. For more info: http://www.energystar.gov/index.cfm?c=refrig.pr_refrigerators

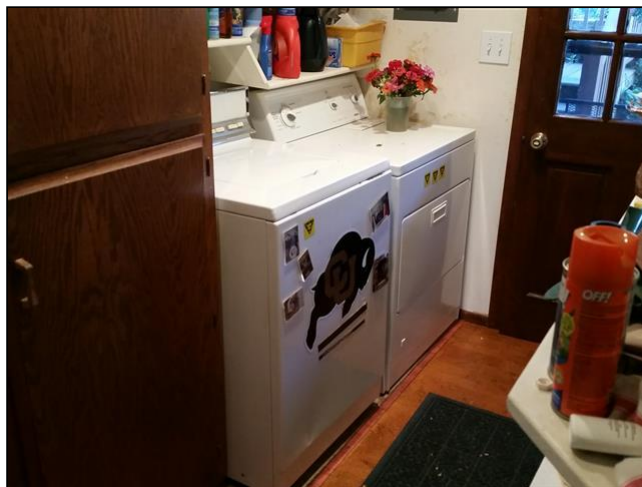
8.1 Item 1(Picture)

Washer/Dryer: Your washer/dryer units are older and likely consume more electricity and water than newer, energy efficient units. Consider replacing with Energy Star rated units when possible. Visit; http://www.energystar.gov/index.cfm?c=clotheswash.pr_clothes_washers
