Scott Home Inspection, LLC

Inspection Picture of the Month:

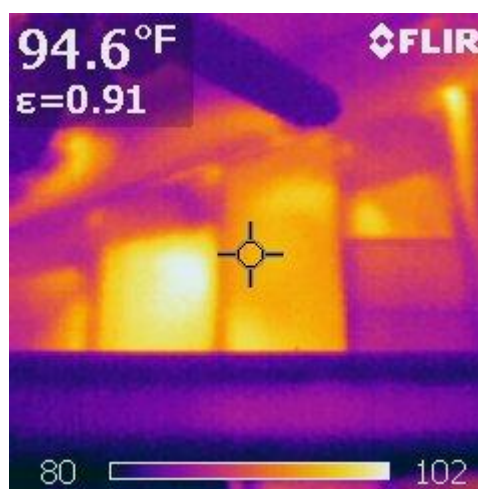
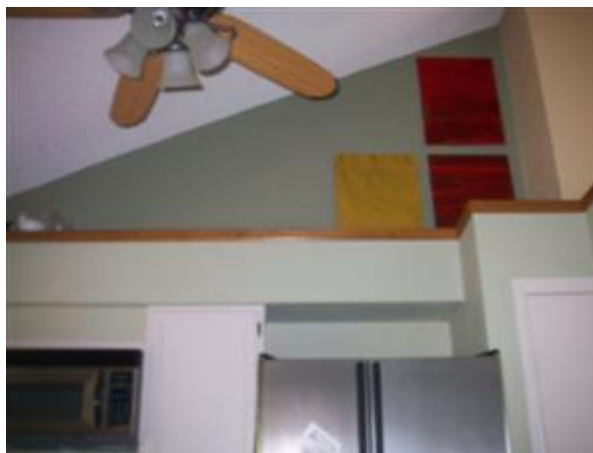
Oh where, oh where did all the insulation go: The owner of this new home was complaining that the home was very hot in winter and hard to heat in winter.

Investigation with an infra-red camera showed that the insulation along all of the upper attic knee walls was completely missing. With no insulation in these areas, all along the upper section of the home, the heat gain in summer, and heat loss in winter was tremendous.

New home inspections and 1-year warranty inspections can help to find areas like this, where a lack of quality control results in direct comfort issues with the occupants.
