Inspection Connection

e-Newsletter from Scott Home Inspection

JANUARY, 2010

Inspection Picture of the Month:

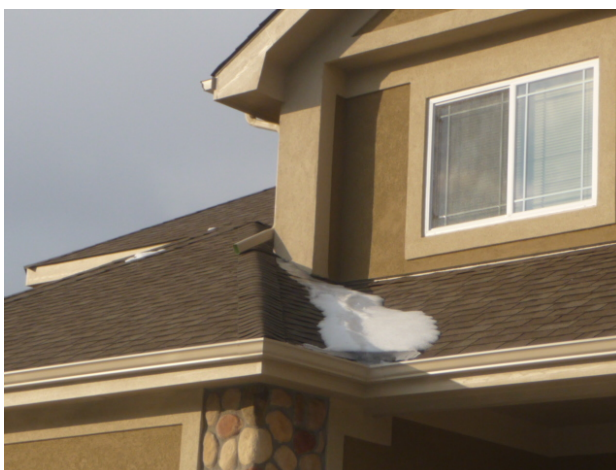
Ice Damming Damage: Architectural features of new homes often include small areas where a valley is created in the roof. A valley like this can trap snow and ice, and block proper drainage from occurring.

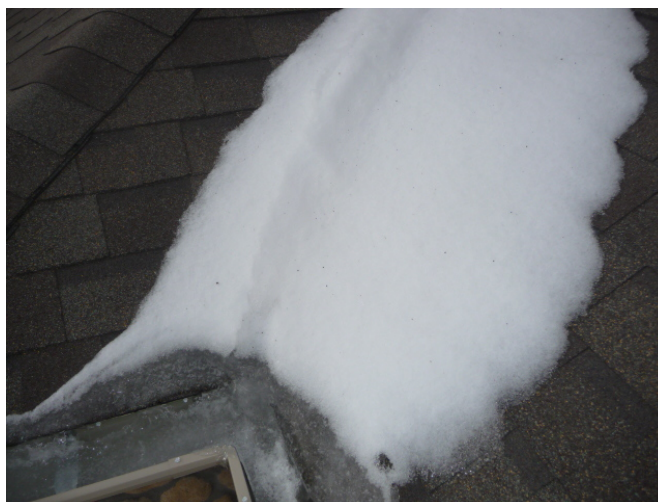
Combined with improper flashing at the gutter edge, wicking of moisture can occur under the roof edge, and cause soffit panel damage, and even cause moisture to wick and leak into the home.

In this home, proper edge flashing under the gutter was missing, and moisture wicked into the home damaging drywall and creating a leak. Small details in construction can cause expensive repair issues. Inspecting the flashing on gutters is a small but important part of a home inspection.
