Scott Home Inspection, LLC

Inspection Picture of the Month:

Got Insulation? It wasn't difficult to see that this house is poorly insulated on half of the home.

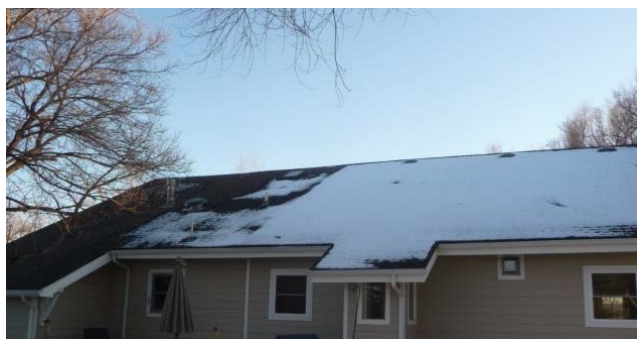
This was a north side roof, with the snow still present over half of the home, and the snow mostly melted on the other half. This is an indication that there is less insulation on the melted half, as the heat from the home is escaping easier, and melting off the snow quicker. This condition can lead to ice-damming and other issues on the roof, not to mention the loss of heat and comfort issues on this part of the house.

Further inspection revealed that the home had been remodeled and re-insulated on the half of the home with the snow still present, and yet was older and poorly insulated on the melted half. Re-insulation of this half of the home was recommended, as an upgrade to the home. While the presence of snow prevents complete inspection of the roof, there are often other things we can determine from looking at a snow covered roof.
