Scott Home Inspection, LLC

Inspection Picture of the Month:

Crawlspace Surprise... Many of the newer homes in Colorado have Pier style foundations, with engineered floors where a lower crawlspace is present underneath the basement floor. Ventilation of these lower crawlspaces is critical. A humidistat venting system is usually installed, and a plastic sheet vapor barrier should be installed over the soil.

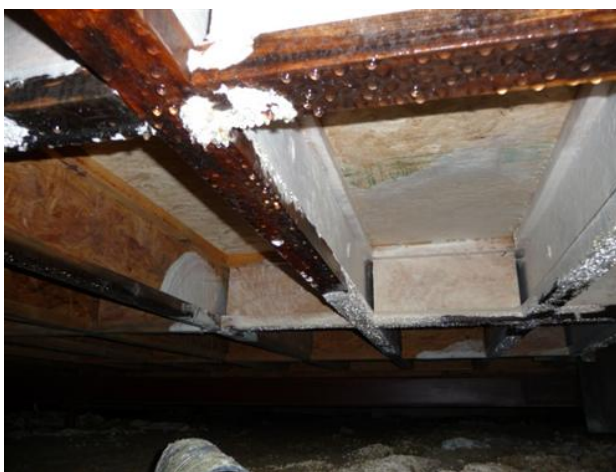
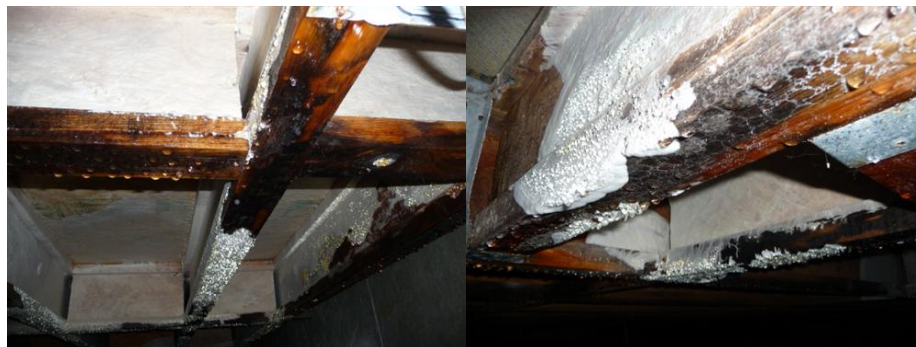
When that vapor barrier is missing, exposing the soil, and then the ventilation fan happens to fail, surprising things can happen...

Here are pictures from a crawlspace recently discovered, where the ventilation fan had died, and there was no vapor barrier over the soil. The homeowner was complaining of health and respiratory issues. Mold was present throughout the crawlspace, and the fan was not running.

Mold is never fun to discover or deal with during a real-estate transaction. Homeowners should check the operation of the ventilation system in this type of home, and when possible, a plastic sheet vapor barrier should be installed over the soil, in the event the fan does fail.
