Scott Home Inspection, LLC
Complete Home Performance Assessment
970-532-2424
www.ScottHomeInspection.com

Inspection Report

Property Address:
456 Elsewhere Ct
Boulder CO

Inspection Date:
9/2/2014

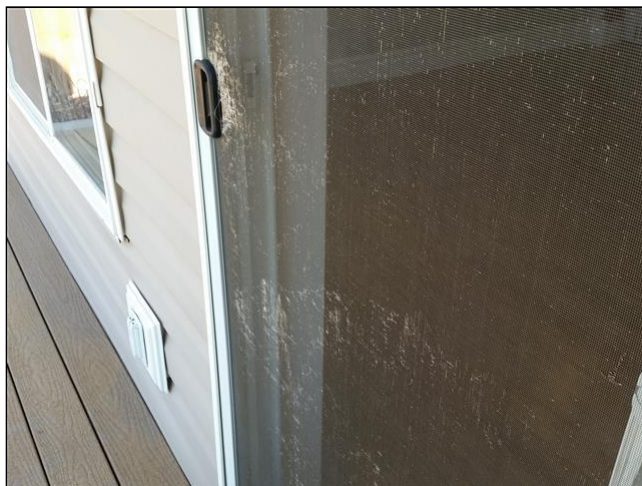
1.2 Item 2(Picture)

The screen door at the sliding glass door is damaged and torn. A screen door repair or replacement is needed.

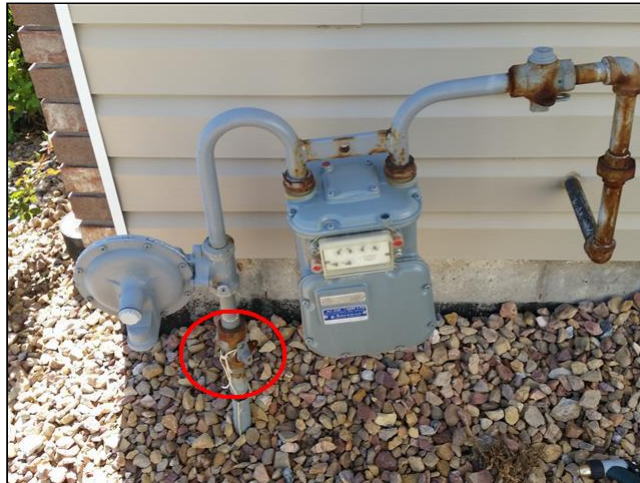
4.0 Item 1(Picture)

The main fuel shut off is at gas meter outside.

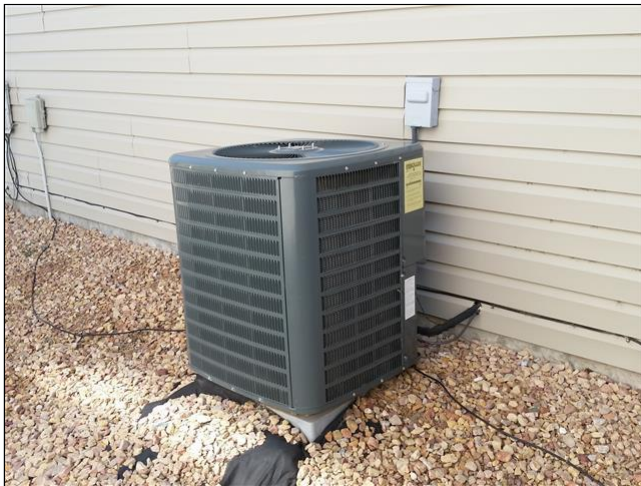
7.0 Item 1(Picture)

The AC system was fully tested and appears to be operating properly. The temperature drop across the system supply vs. return ducts was measured at the furnace. A temperature drop of at least 15F is expected. The system operated well with a temperature drop in excess of this minimum expected level.

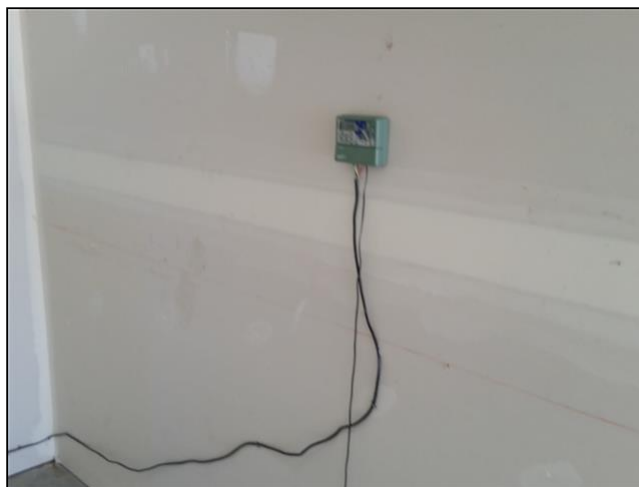
11.1 Item 1(Picture)

The controller for the sprinkler system is located in the garage.
