Scott Home Inspection, LLC

Inspection Picture of the Month:

Safety items are #1 Priority for any inspector... When we come across a very old furnace, it is critical to test the unit for combustion safety.

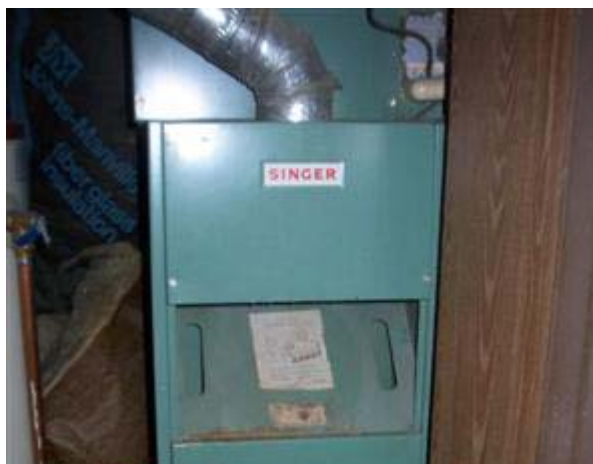
The right tool for this job is a combustion analyzer that can probe the flue, and measure the Carbon-Monoxide levels, Oxygen levels, and calculate operational Efficiency. Levels of Carbon-Monoxide measured in the flue should be less than 100 PPM (Parts-per-Million). This particular furnace was reading 1149 PPM of Carbon Monoxide in the exhaust flue!

The heat exchanger had visible rusting present throughout, and the Carbon-Monoxide measured at a room heat register was approx 25 PPM. Levels above 50 PPM in the air can cause serious health issues. The furnace was recommended to be replaced, and the realtor advised the current tenants about the health risk potential. Safety is everyone's responsibility, with combustion safety a top priority for inspectors.
